## Power Equipment

CODE: CC-289 (REVISED 9/30/94. DESTROY ALL PREVIOUS COPIES)

DATE: SEPTEMBER 23, 1994

SUBJECT: POWER TAKE OFF (PTO) CLUTCH FAILURES 2185 CUB CADET.

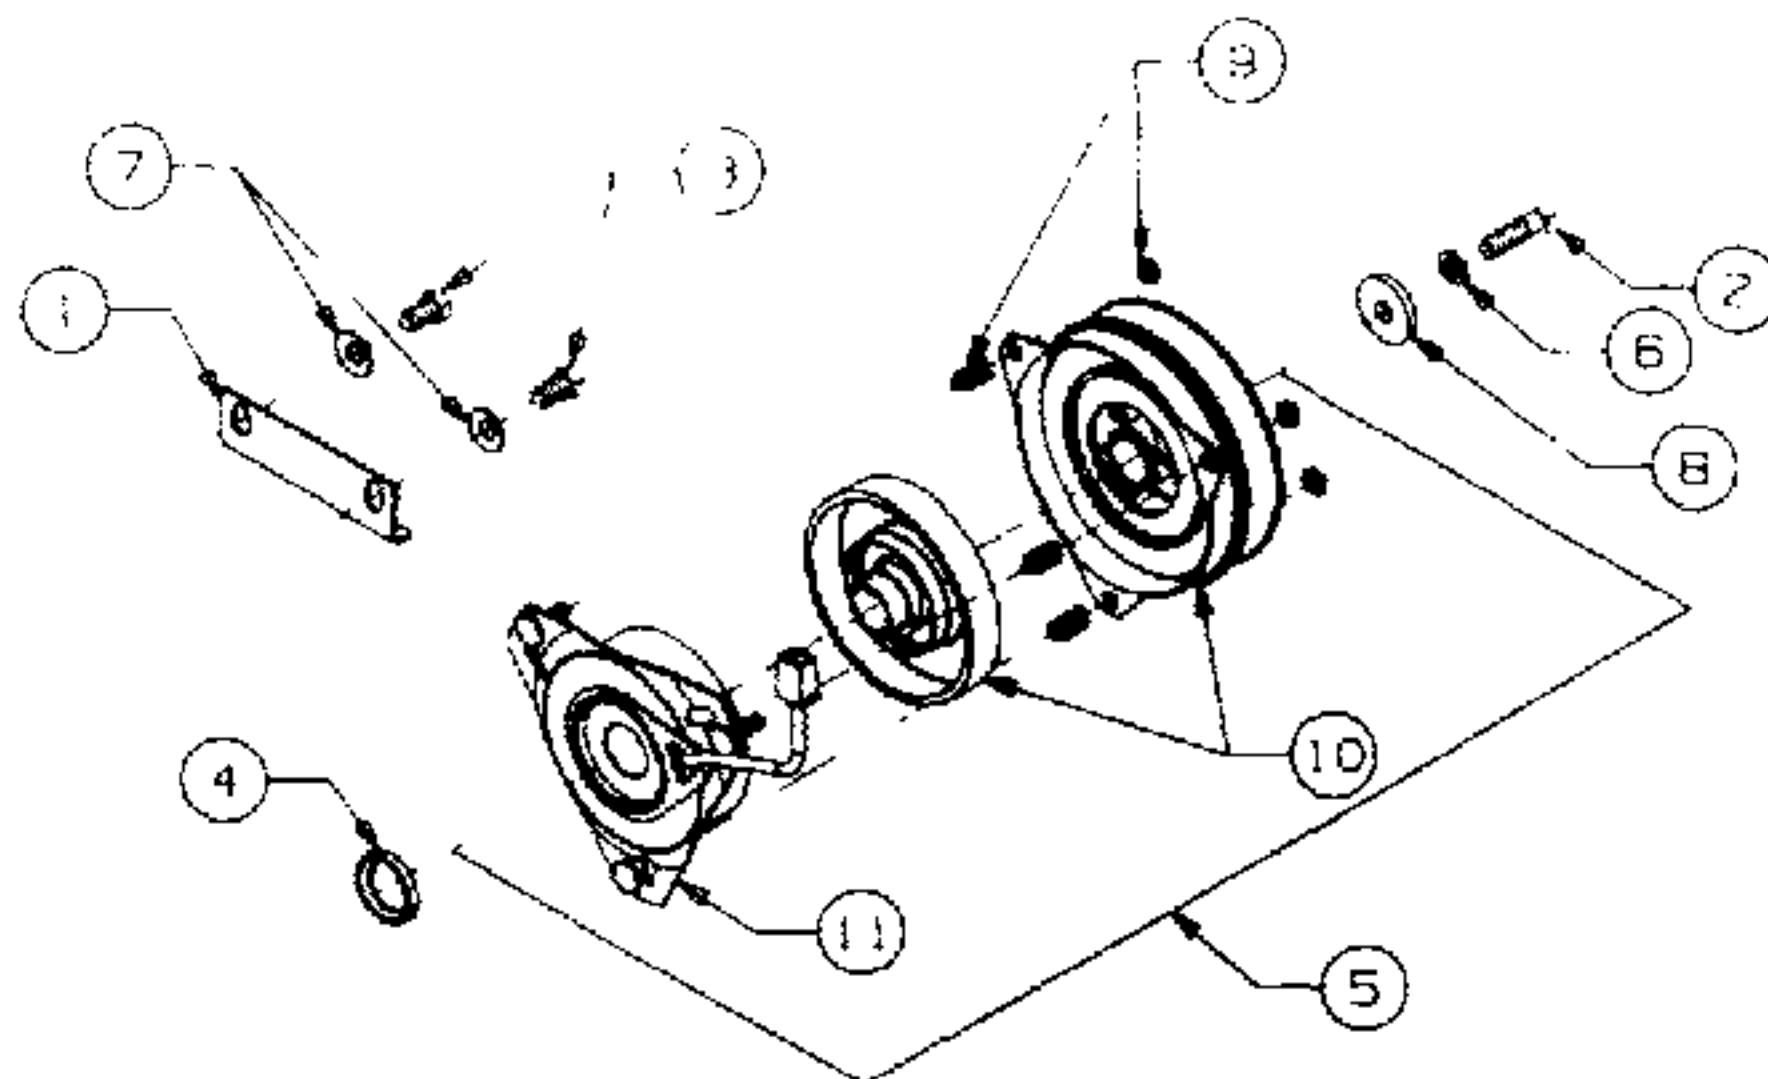
Reports from the field indicate difficulties with the above mentioned tractors PTO clutch including, clutch bearing failures, field winding failures or exposed field windings.

Failures seem to be caused by improper clamping of the PTO clutch to the engine crankshaft. If it does not fit tight against the spacer the above examples may occur. Should you experience the above symptoms or failures, the following should be done.

Order a second spacer, part no. 711-3396, (See fig. 4) and install it on the crankshaft with the existing spacer. Install the PTO clutch, making sure that the clutch fits against the spacers. Once it has been verified that clutch to spacer contact has been achieved, with no other interference, install the retaining bolt, lock washer and retaining washer into the crankshaft. Torque to 50-60 ft. lb..
