LAWN TRACTOR

Troy-Bilt Models Affected: **Super Bronco 46 Hydro** (13AJA1BT066).
Super Bronco 46 XP (13AJA1BN066).
Super Bronco XP 50 FAB (13AJA1BZ066, 13BJA1BZ066).
Super Bronco 54 (13AJA2BW066).

Date: April 22, 2020 **Revised November 13, 2020 (Please Destroy All Previous Copies).**

Subject: **Battery Current Draw**

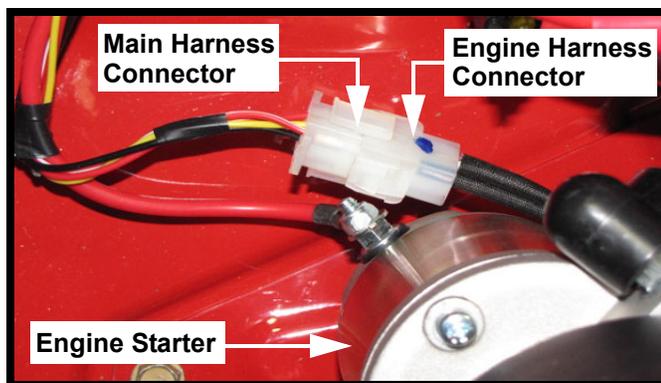
FIGURE 1

1. Park the tractor on a flat level surface and engage the parking brake.
2. Disconnect the negative battery cable from the negative battery terminal.
3. Locate the 6 pin female engine harness connector and the 6 pin male main harness connector located on the starter side of the engine. See Figure 1.

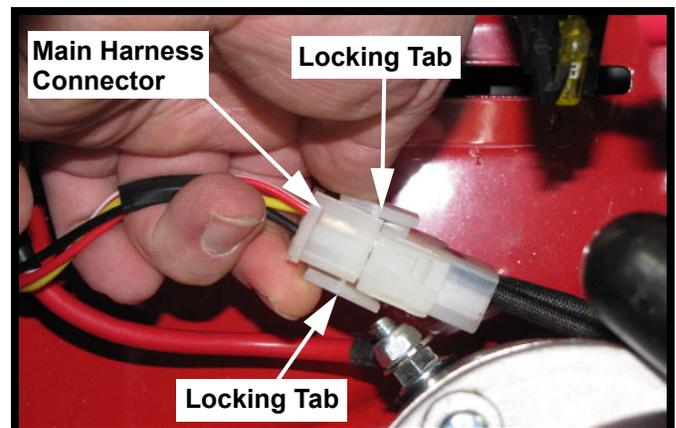
FIGURE 2

4. Disconnect the main harness connector from the engine harness connector by squeezing the two locking tabs on the main harness connector as shown in Figure 2, then separate the connectors.
