Power Equipment

CODE: CC-275

DATE: APRIL 15, 1994

SUBJECT: INTERMITTENT SCRAPING NOISE COMING FROM TRANSAXLE ON 2000 SERIES HYDROSTATIC DRIVE TRACTORS. (2135-2145-2165-2185)

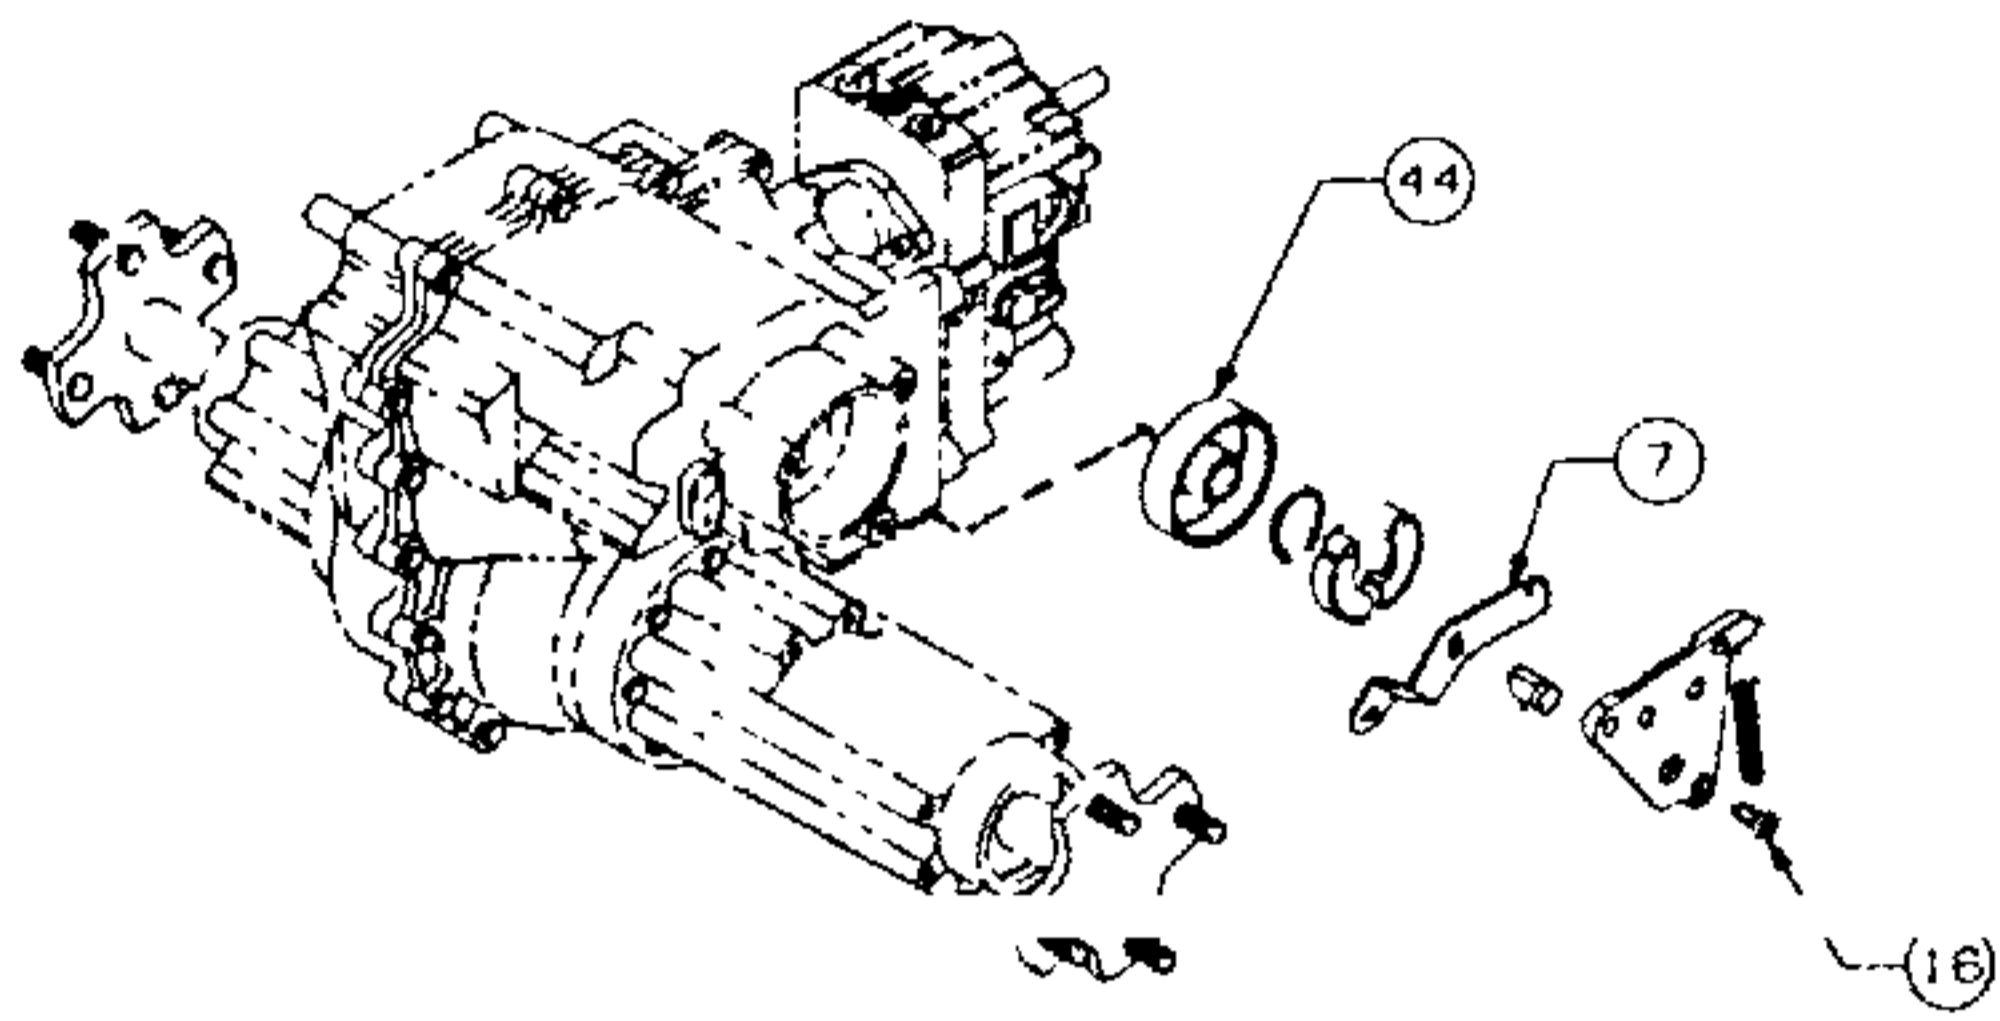
The brake drum on the 2000 Series hydrostatic drive tractors, part no. 761-3019 see item 44, is allowed to be a free floating drum. Because of this the brake drum may move outward slightly and contact the brake actuating arm, part no. 703-2191 see item 7, causing a scraping noise. Should you experience this situation proceed as follows:

- 1) Order a new brake drum, part no. 761-3019. The new drum has been machined slightly thinner to give more clearance between the drum and the brake actuator arm.

- 2) Remove the transaxle assembly from the frame of the tractor.
- 3) Remove the one remaining screw that attaches the brake mechanism to the transaxle. See item 16

- 4) Carefully remove the brake mechanism from the transaxle being careful not to lose any parts.
- 5) Remove the old brake drum from the brake shaft and install the new thinner brake drum.

- 6) Reassemble the brake parts back on to the transaxle and secure the assembly with the one screw previously removed. NOTE: When installing the one screw, to retain the brake mechanism, gently apply the brake before completely securing the screw. This will help align the other two screw holes which will assist you when installing the transaxle back into the frame of the tractor.

- 7) Reinstall transaxle back into tractor frame and connect all mounting and linkage parts on to tractor. NOTE: Add loctite 262 to mounting bolts and torque to 21-24 ft. lbs.
