Service Advisory

CC-674

Models Affected: All MMZ TANK Units

Subject: **Red Positive Battery Cable Routing.**

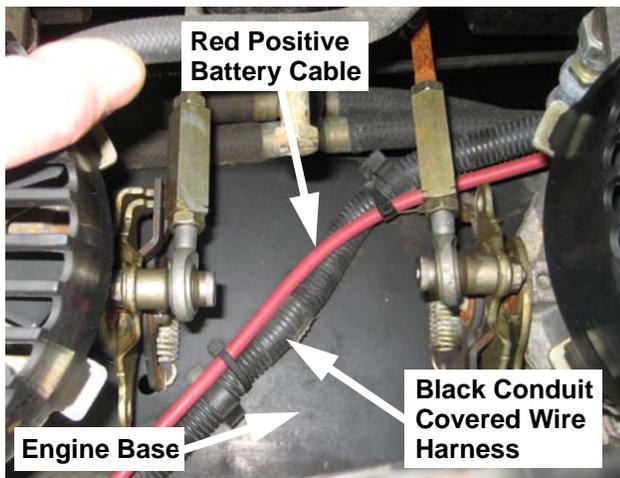
FIGURE 1

PURPOSE: The red positive battery cable routing from the battery to the starter solenoid may be too close to the RH hydraulic pump linkage. The hydraulic pump linkage can wear into the insulation of the red positive battery cable causing a short circuit.

1. Park the unit on a flat level surface.
2. Engage the parking brake.
3. Visually check the red positive battery cable routing. The red positive battery cable should be routed and secured to the black conduit covered wire harness as shown in Figure 1.
