# Service Advisory

CC-497

Subject: Transmission drive belt tensioner spring may come off, and Idler bracket rattle noise

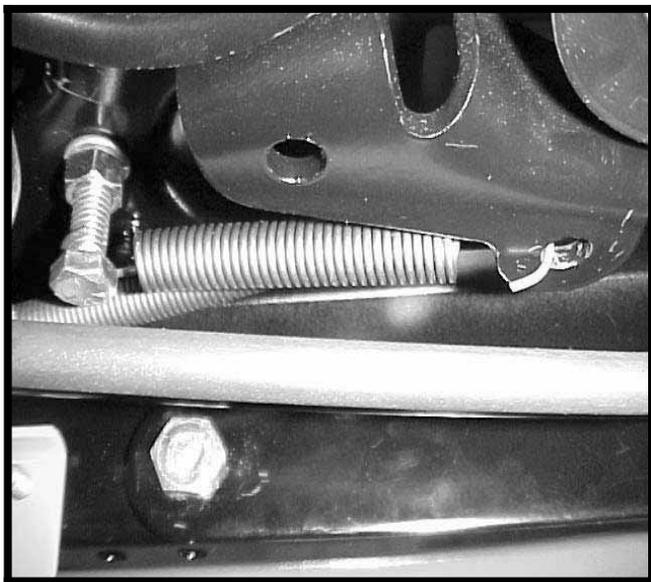
**Figure 2.**

**SYMPTOM 1:** Under certain operating conditions, i.e. heavy loading on the transmission drive, the hydrostatic transmission drive belt tensioner spring may come off from its bolt anchoring point. This will result in a loss of drive to the hydrostatic transmission.

1. Locate and remove the existing idler extension spring 732-0429A.
2. Install the new extension spring **732-04323B**. The spring must be hooked at the lowest point on the anchor bolt next to the head as shown in Figure 2.

14. Install the new extension spring **732-04323B**. The spring must be hooked at the lowest point on the anchor bolt next to the head as shown in Figure 2.

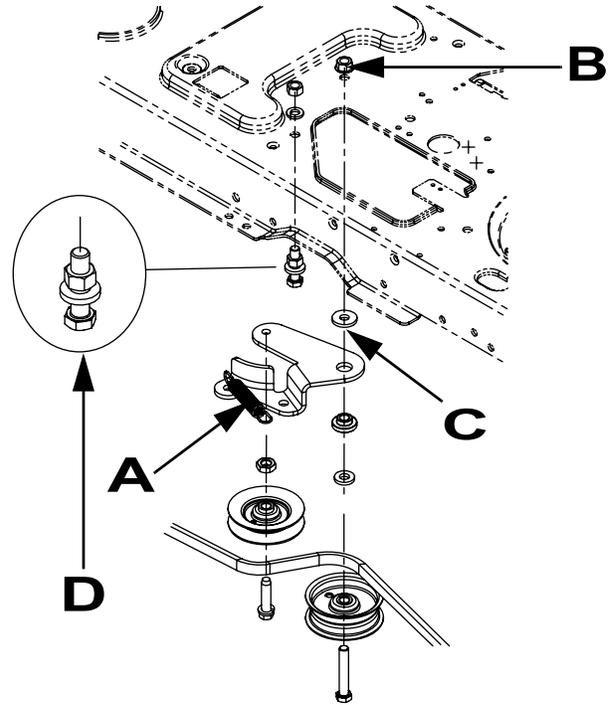
Figure 3.

**SYMPTOM 2:** If the unit is experiencing a ticking, or knocking noise during operation. The flat washer located between the idler bracket and frame needs to be replaced with a smaller O.D. flat washer. Washer and the appropriate safety label per model listed below.

**NOTE:** *There may be a floating flat washer "D" on the spring anchor bolt. The floating washer is not needed when using the new style extension spring, but can be left in place.* (Figure 3).

10. Disconnect the extension spring "A" from it's anchor bolt. (Figure 3). Remove the drive belt off of the fixed idler on the left underside of the frame (not shown).

11. Remove the idler bracket pivot bolt nut "B" and lower the idler bracket assembly. (Figure 3).

12. Discard the flat washer "C" and install the new flat washer **736-0258** in it's place. (Figure 3). Re-install the idler bracket assembly using the removed hardware.
