Service Advisory

CC-641

Models Affected: i1050 (17AF9BKP010).

Subject: **Premature Belt Wear Due To Extreme Angle.**

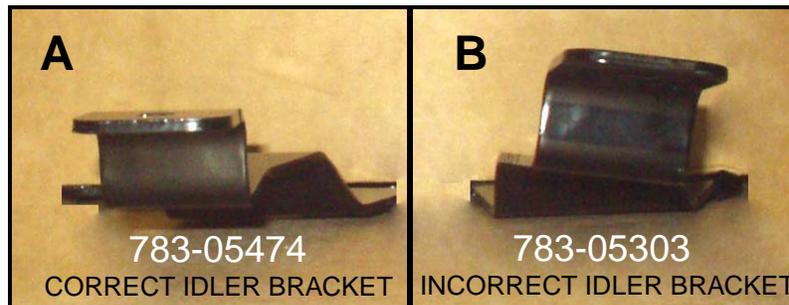
FIGURE 1

PURPOSE: The incorrect deck idler bracket (783-05303), may have been installed causing the deck idler pulley to be at such an angle it causes the belt to fray on the bottom edge due to the idler pulley flange cutting it.

1. Place tractor on a flat and level surface.
2. Turn off the engine, remove the ignition key and set the parking brake ON.
3. Inspect the existing deck idler bracket. If the existing idler bracket is a 783-05474, as shown in Figure 1A, the correct bracket is installed. Stop here. Any deck belt wear is the result of some other reason and further analysis is required.

If the idler bracket is a 783-05303, as shown Figure 1B, the incorrect bracket was installed. Order a 783-05474-0637 Idler Bracket and, if required, a new belt 754-04077. Proceed to Step 4.

4. Using a 3/8" drive breaker bar in the 3/8" square hole in the idler bracket, release the deck drive belt tension and remove the belt from the idler pulley. Remove the belt from the engine PTO.
5. Remove the deck from under the tractor.
6. Slip the belt off of the idler pulley. Unhook the extension spring from its' mounting post and idler bracket mounting hole.
7. Using a 9/16" socket and ratchet and a 9/16" box/open end wrench, remove and retain the 3/8"-16 bolt, spacer washer and lock nut securing the idler bracket to the deck. Remove the idler bracket/ pulley subassembly.

8. Using a 9/16" socket and ratchet and a 9/16" box/open end wrench, remove and retain the 3/8"-16 bolt, both flat washers and lock nut securing the 756-04129 (4.25" diameter) idler pulley to the idler bracket. Discard the idler bracket.

9. Install the pulley onto the new 783-05474 idler bracket with the hardware removed in Step 8. Ensure that there is a flat washer on either side of the pulley hub.

10. Install the new idler bracket/pulley subassembly onto the deck with the hardware removed in Step 7.
11. Re-install the extension spring onto the idler bracket and its' mounting post.

12. Install the belt onto the idler pulley ensuring that the belt is correctly routed and on all pulleys.
13. Re-install the deck onto the tractor.
14. Using a 3/8" drive breaker bar in the 3/8" square hole in the idler bracket, move the idler bracket forward to provide additional belt travel, reconnect the deck belt to the engine PTO. Release the idler bracket.
