CODE: CC-278

DATE: APRIL 27, 1994

SUBJECT: POSSIBLE TRANSMISSION CLUTCH ROD MISLOCATED ON 2000 SERIES TRACTORS. (MODELS 2130-2185)

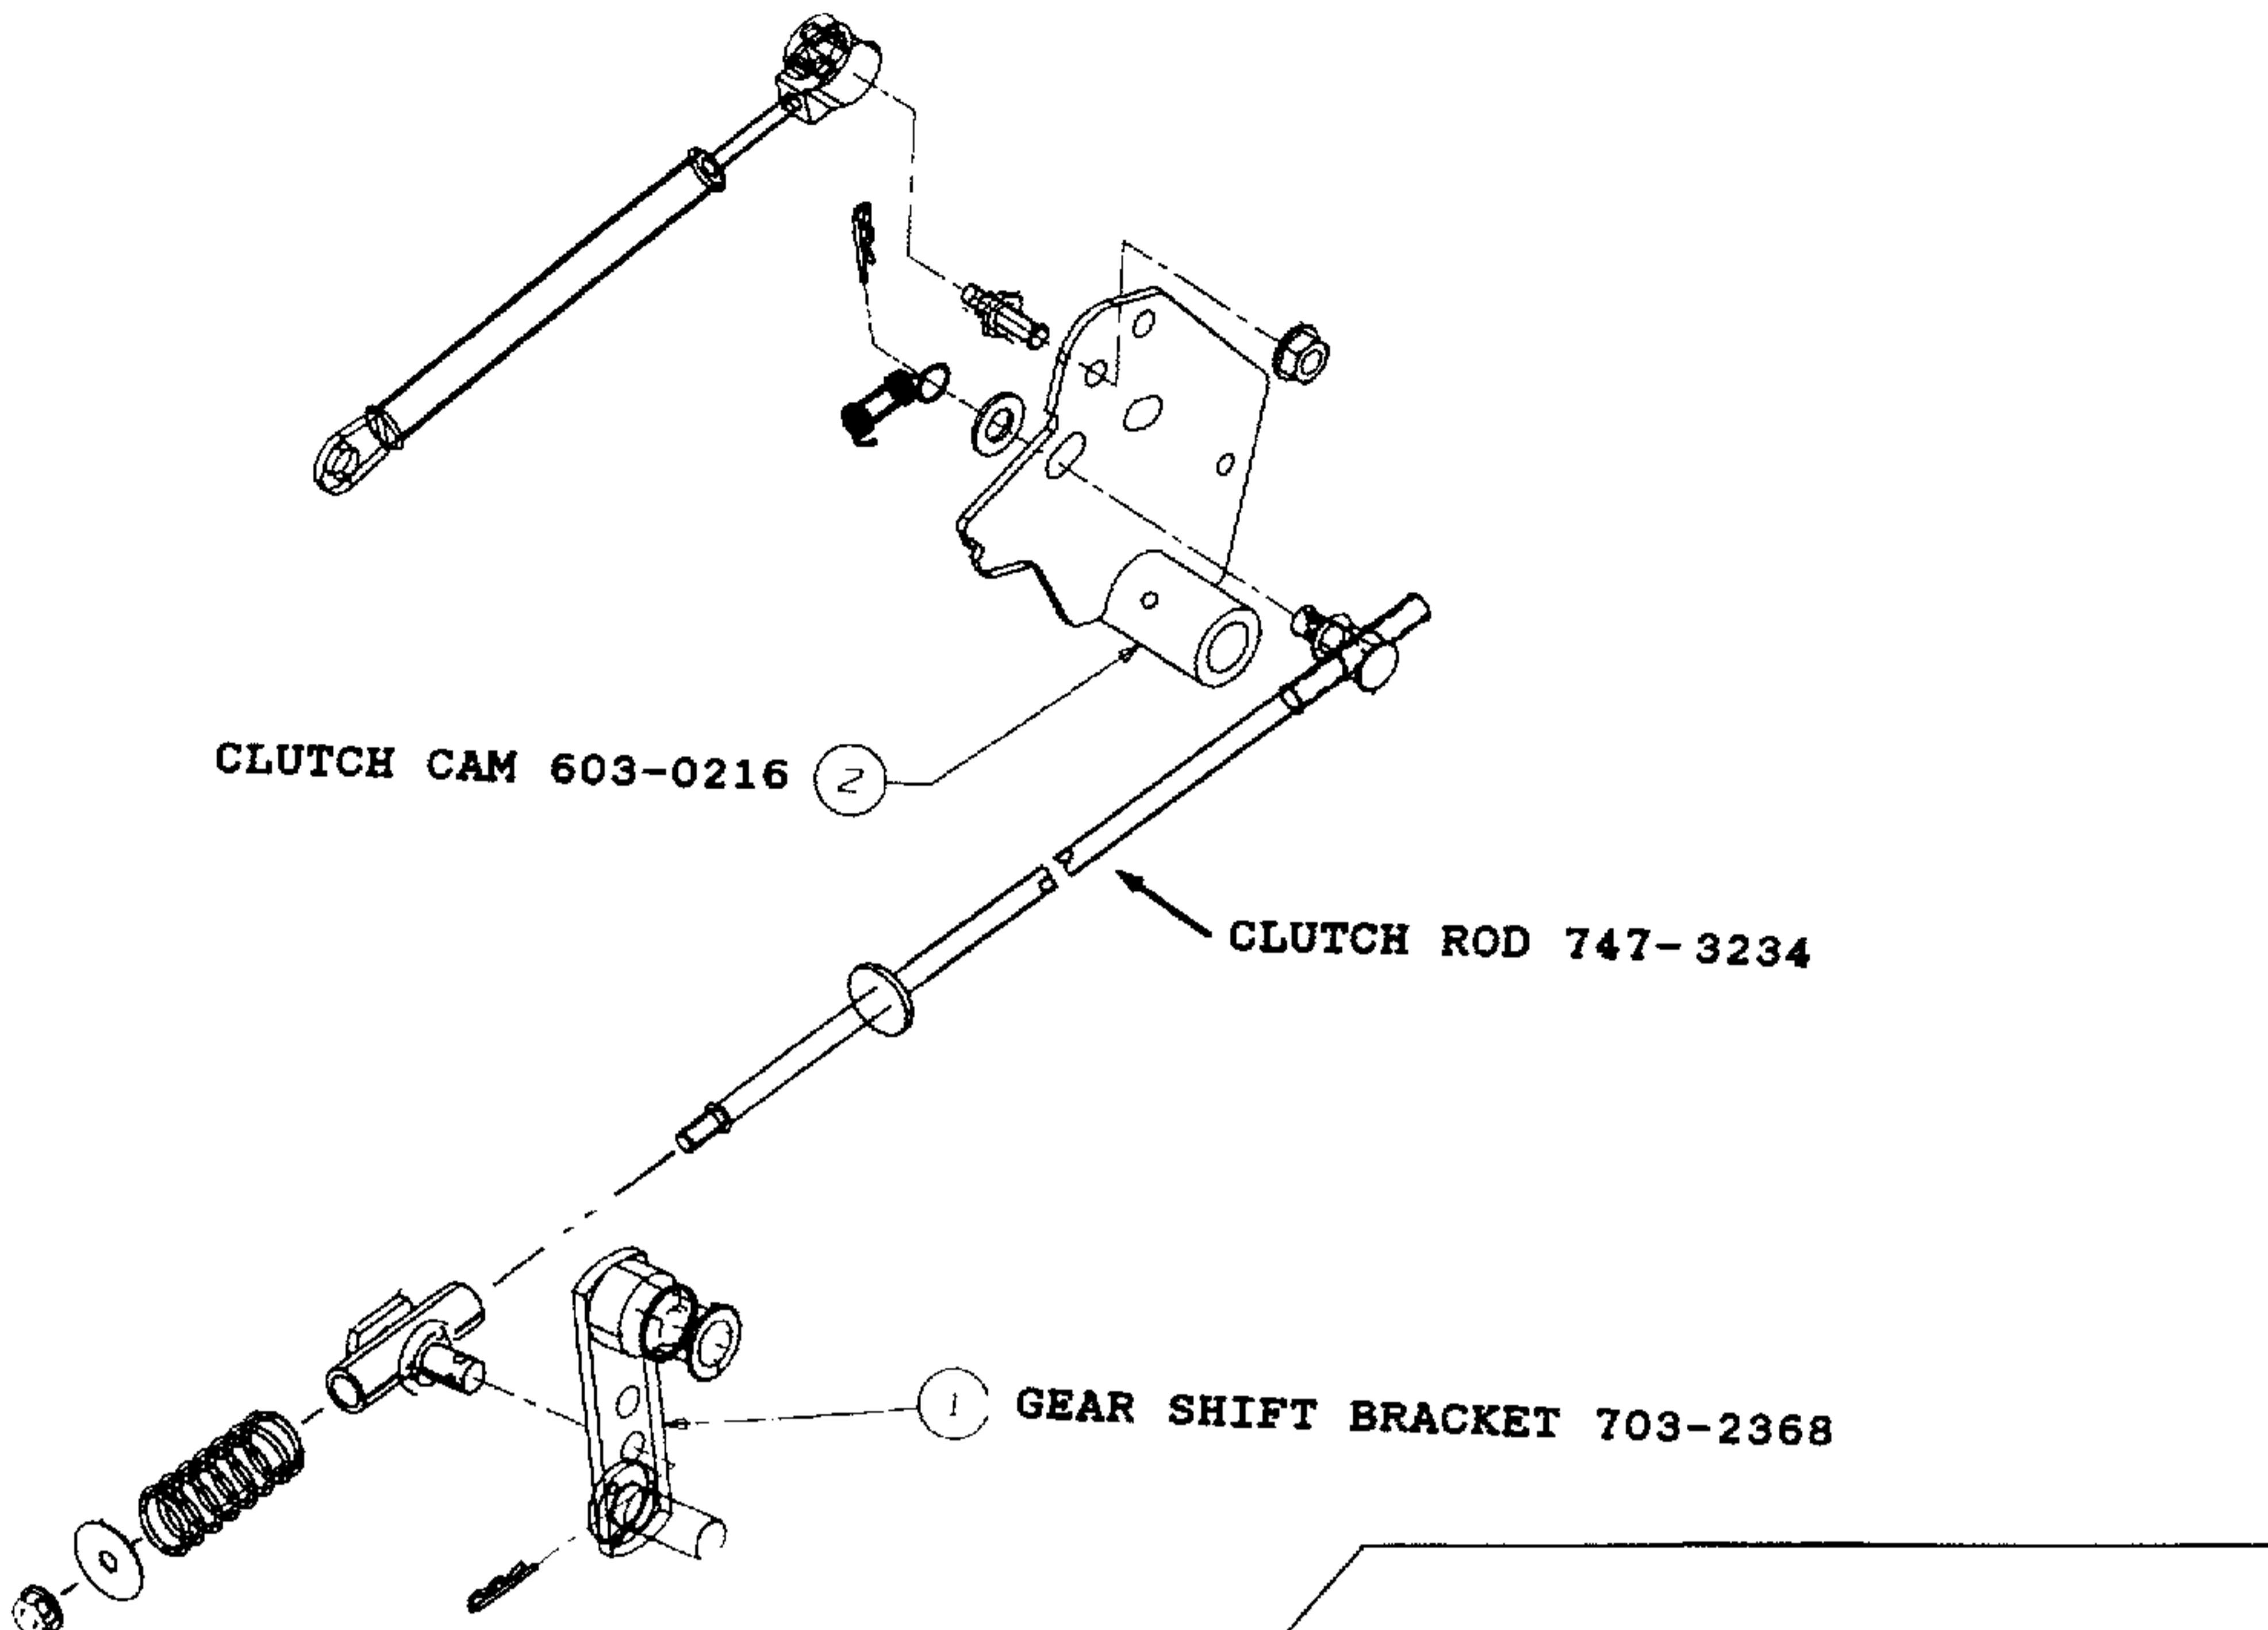
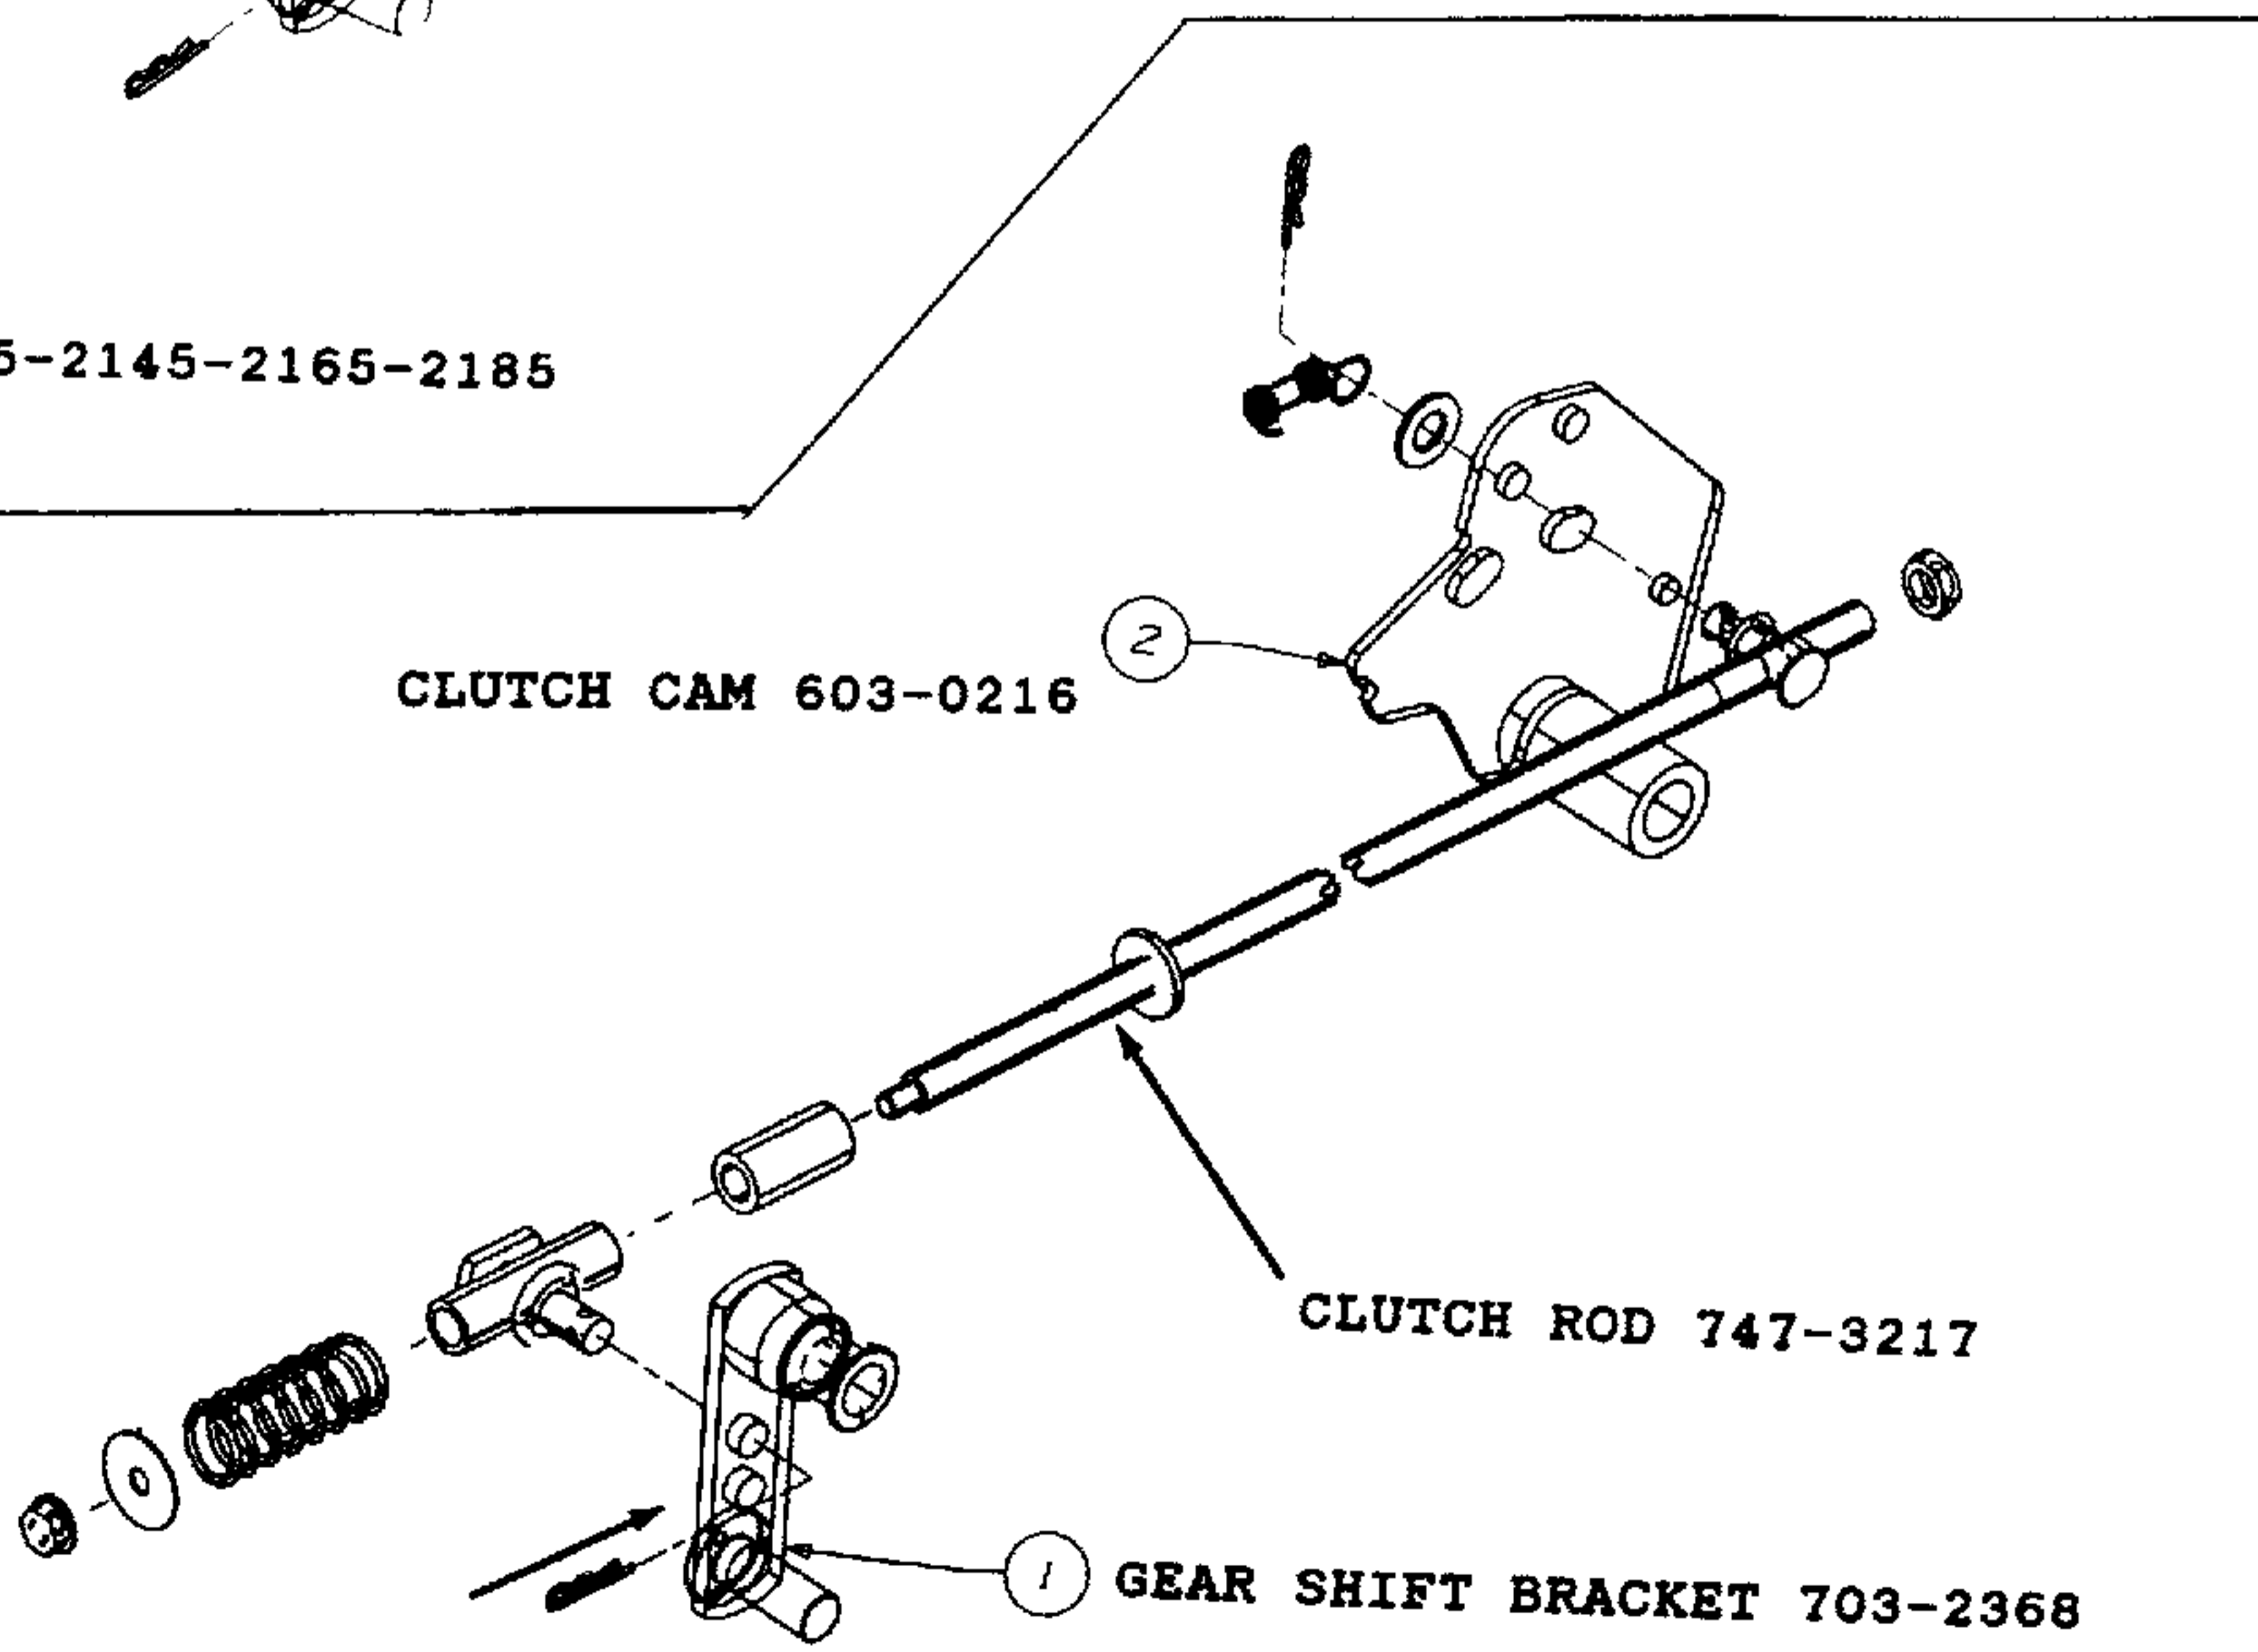
Transmission adjustable clutch rod may have been inadvertently mislocated on the above tractors. Should this occur you will experience improper operation of the transmission. It will be slow and unresponsive in forward or reverse and lacks power. (Transmission torque).

Look at the attached parts diagrams and determine which diagram applies to your specific tractor. Install the clutch rod (item no. 3) and its respective parts, into the proper hole location at each end of the clutch rod. (FRONT ROD INSTALL IN CLUTCH CAM ASSEMBLY item no.2 REAR ROD INSTALL IN GEAR SHIFT BRACKET item no. 1)

NOTE: ALL ADJUSTMENTS SHOULD BE MADE AT THE FRONT ROD FERRULE

- 1) Depress the brake pedal and lock into place.
- 2) Adjust the ferrule until the rod can be installed at the back of the slot. (Towards the rear of tractor)
- 3) Check for proper operation of the tractor.
