THIS IS A MANDATORY INSPECTION

CODE: CC-291

SUBJECT: SERIES 2000 TRANSMISSION AXLE RETAINING RING, (MODELS 2130 - 2185) REGARDING TRACTORS WITH BUILD DATE CODES BETWEEN: K164G - K214G.

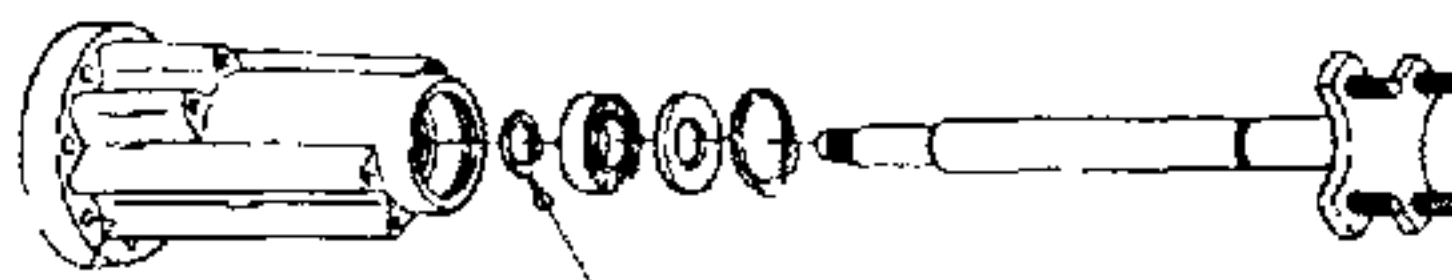
RETAINING RING (716-3018)

PROBLEM: WE HAVE FOUND IN SOME INSTANCES THAT THE RIGHT AXLE RETAINING RING HAS BEEN INSTALLED IMPROPERLY.

INSPECT THE INNER RETAINING RING TO VERIFY IF THE RING IS PROPERLY SEATED INTO THE GROOVE ON AXLE. NOTE: THERE WILL BE A RING END GAP OF APPROXIMATELY 1/8 OF AN INCH WHEN SEATED IN THE GROOVE.

CLEAN THE SEALING SURFACES OF THE TRANSMISSION AND AXLE HOUSING AND APPLY ULTRA GRAY SEALANT (759-3746) TO ONE OF THE SURFACES. REASSEMBLE THE AXLE HOUSING TO THE TRANSMISSION, TORQUE THE BOLTS TO 180- 200 in. lbs.
