Power Equipment

CODE NO: CC-270

DATE: FEBRUARY 2, 1994

SUBJECT: LOW VOLTAGE LIGHT IMPROPERLY WIRED ON 2135 SERIES TRACTORS, SERIAL NUMBERS 239301 TO 240610.

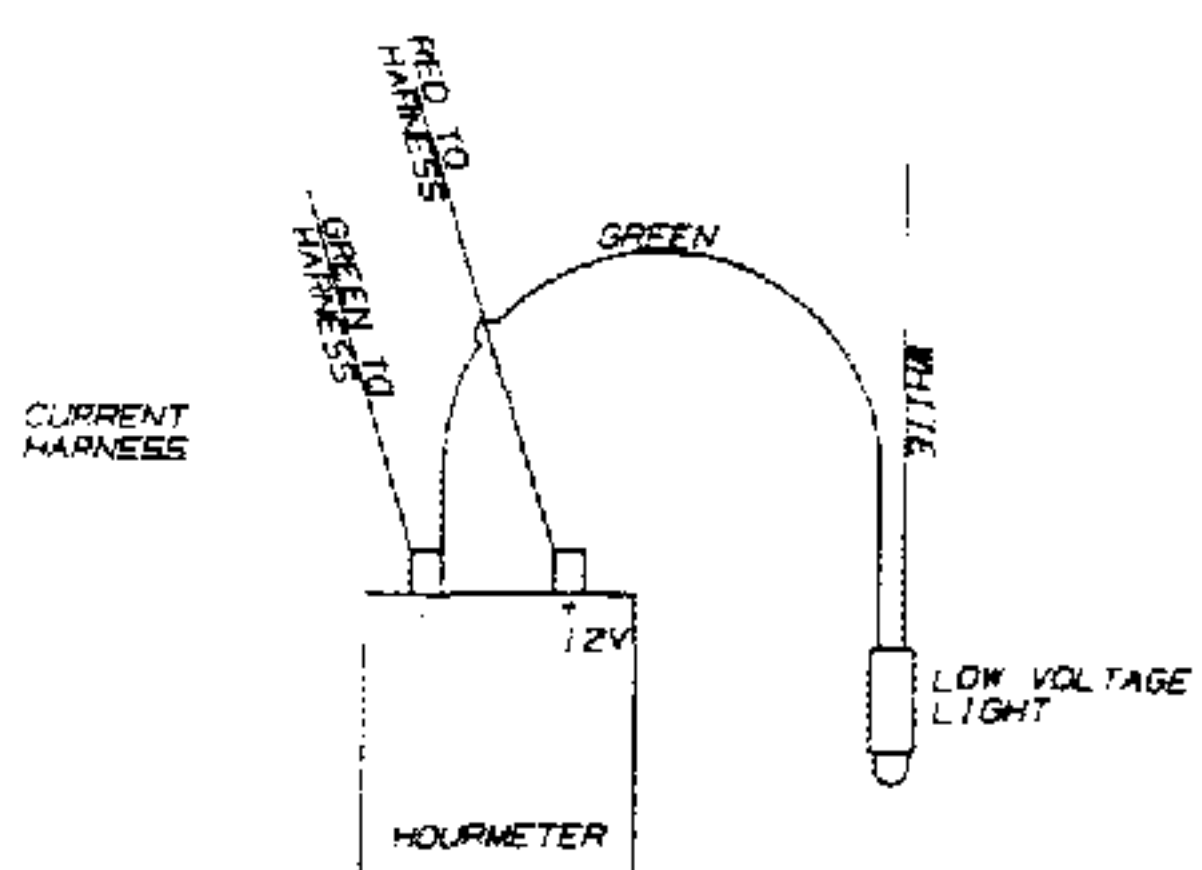
Fig. 1

The low voltage light on the above serial numbered tractors have been improperly wired. It is currently wired as shown in figure 1. See below. As it is wired now the bulb will never illuminate should the battery become discharged.

- 1) Snip the green wire that runs from the low voltage light to the negative side of the hour meter, as close to the hour meter as possible. (See Fig. 1)
- 2) Pull the red wire loose from the positive side of the hour meter and remove the insulator block that covers the terminal end.
- 3) Snip the terminal end from the red wire and strip back the insulation approximately 1/4 inch. Do the same with the green wire you previously snipped from the negative side of the of the hour meter.
- 4) Connect the red and green wires together into one new terminal end and securely clamp together with wire harness pliers. (See fig. 2).
- 5) Reinstall the terminal insulator on the terminal end and reconnect to the positive side of the hour meter.
