Power Equipment

Code: CC-304

Date: June 19, 1995

SUBJECT: POWER TAKE OFF (PTO) CLUTCH SPACER ON 2130, 2135, 2160, 2165, 2185, 1440, 1641 MODEL TRACTORS. (1995 PRODUCTION)

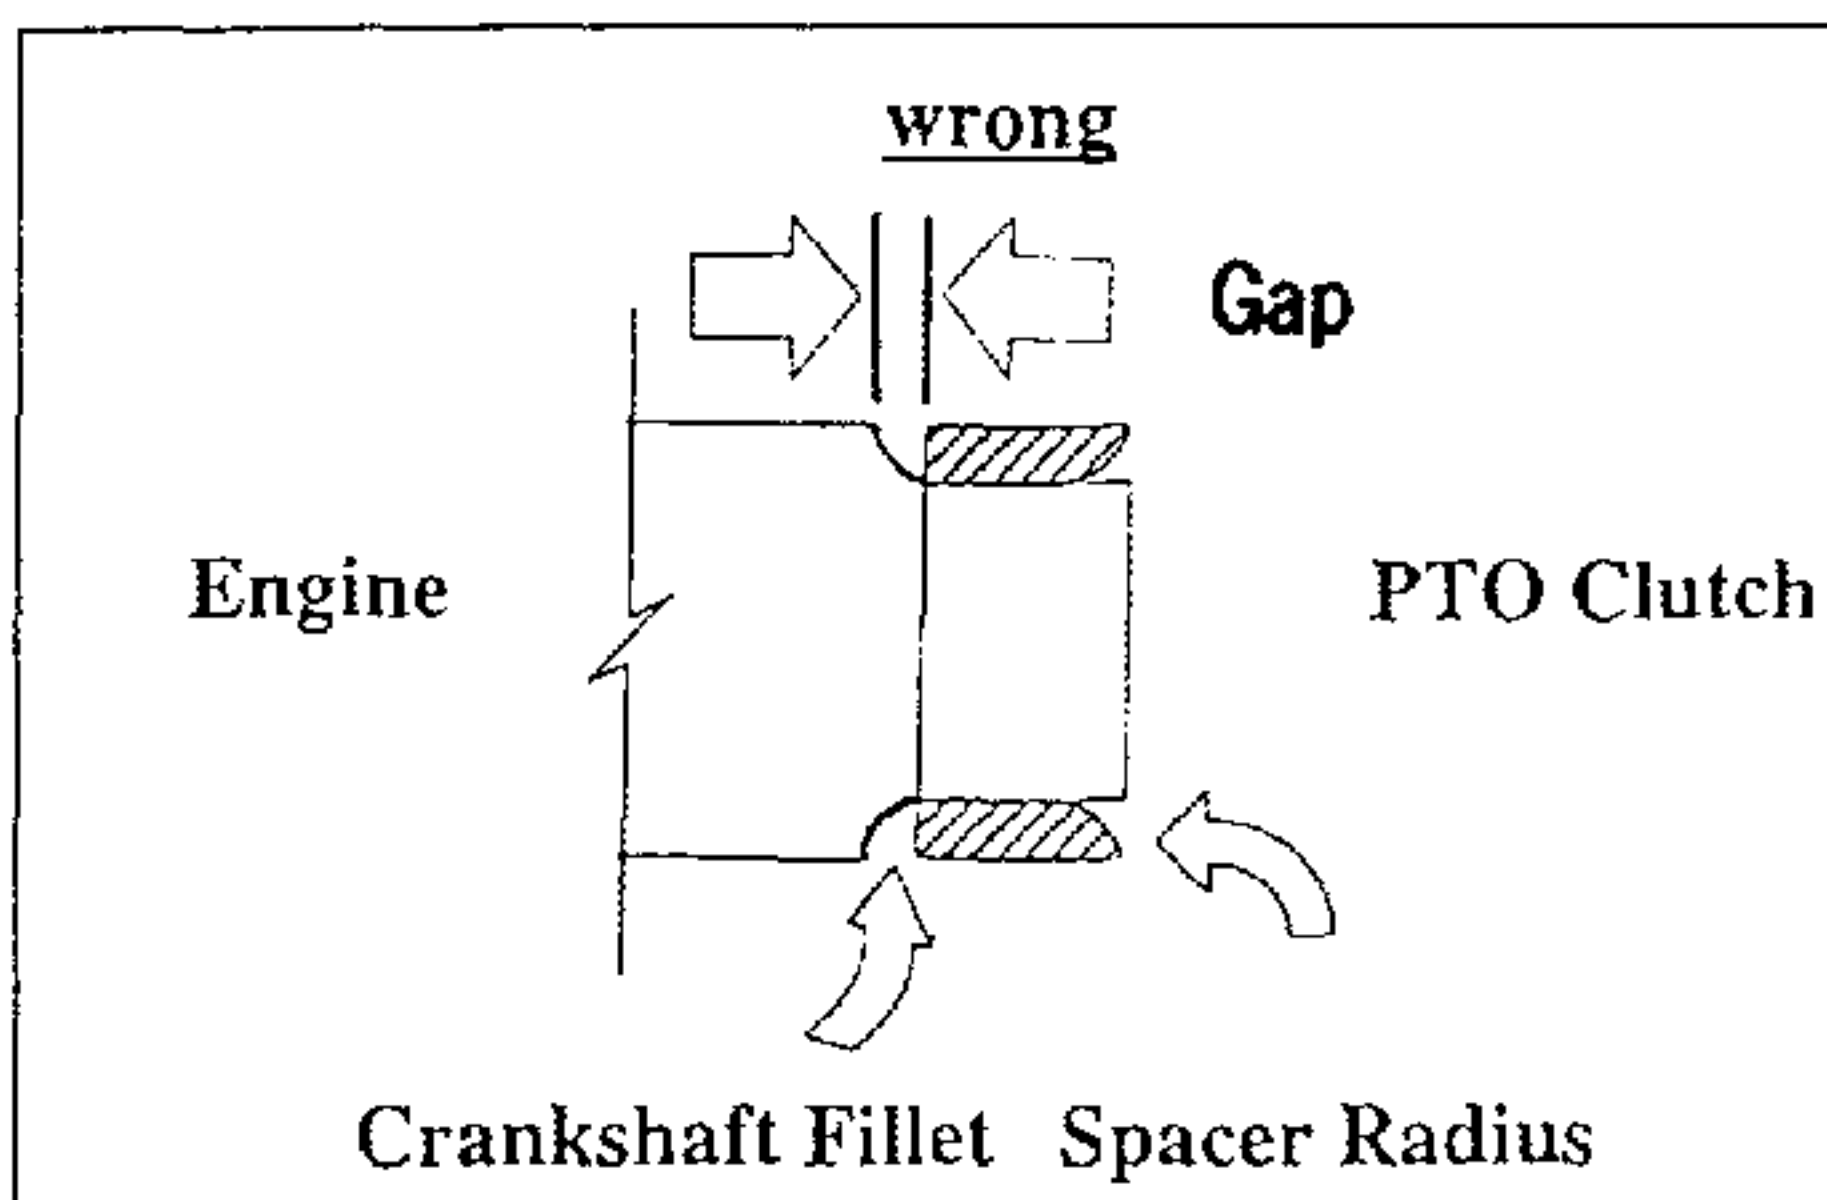
Figure 1

The following instructions are a visual way the service technician can quickly determine if the spacer has been installed properly. First the service technician must remove both side panels from the tractor in an area with plenty of light. Next look behind the PTO clutch, examine the area where the spacer comes in contact with the fillet of the crankshaft as shown in the illustrations below. If improperly installed, a gap will be apparent between the fillet of the crankshaft and the spacer as shown in figure one. If properly installed, the radius of the spacer will be in contact with the fillet of the crankshaft as shown in figure two.
