CODE: CC-293

DATE: DECEMBER 21, 1994

SUBJECT: SERIES 2000 SNOWTHROWERS MODEL 190-303

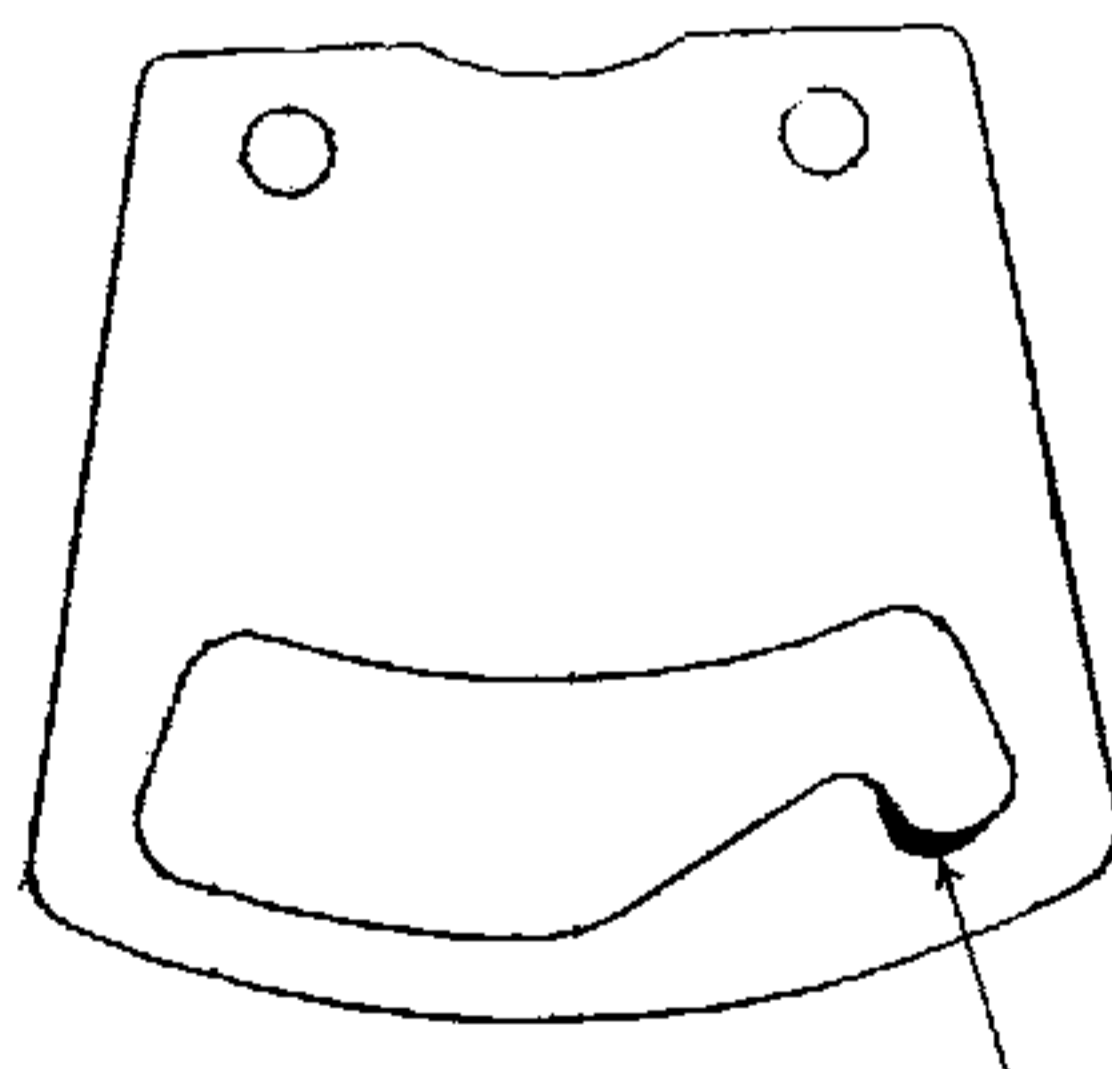
703-2728  
LIFT HANDLE LATCH BRACKET  
FIG. 1

**PROBLEM:** WE HAVE RECEIVED SOME REPORTS FROM THE FIELD OF THE 303 SNOWTHROWERS WHEN IN THE RAISED POSITION, THE LIFT LATCH ROD IS NOT ENGAGED COMPLETELY INTO THE LIFT HANDLE LATCH BRACKET(#703-2728), ALLOWING THE SNOWTHROWER TO BECOME DISENGAGED AND DROP TO THE GROUND.

GRIND HERE

**SOLUTION:** REMOVE THE LIFT HANDLE LATCH BRACKET AND GRIND OUT THE SHADED IN AREA SHOWN IN FIG. 1 BELOW. THIS WILL ALLOW THE LIFT LATCH ROD TO HAVE BETTER ENGAGEMENT.
