Cub Cadet

Service Bulletin

CC-310

Subject: PTO Clutch Relay

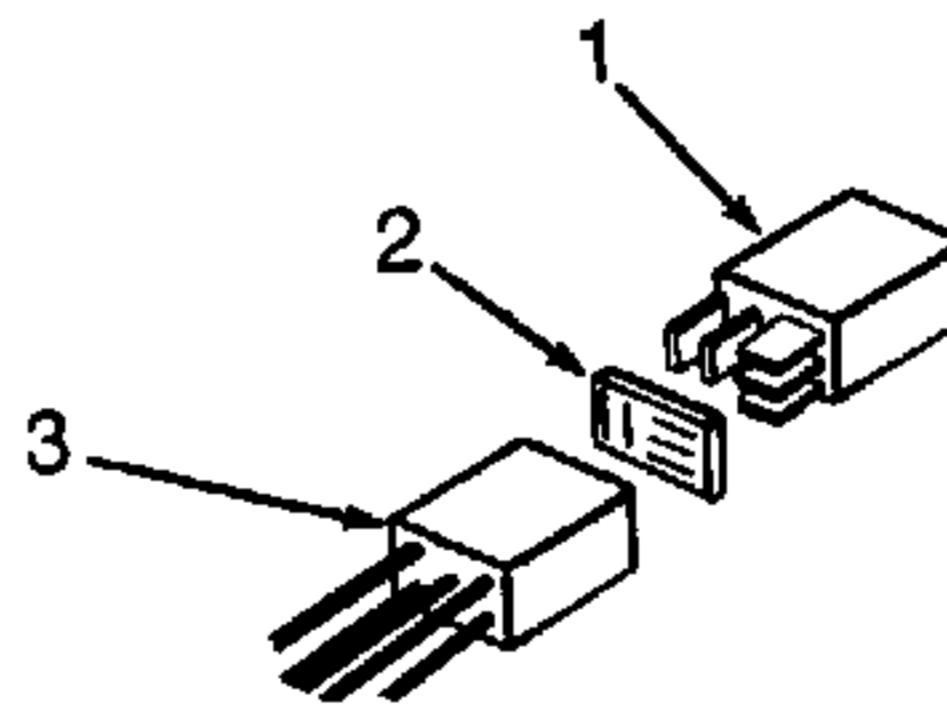
Problem: Field reports indicate the Series 2000 tractor may experience the PTO clutch not engaging when the PTO switch is in the run position. The failure cause has been identified as the 725-1648 PTO relay (1). Further investigation usually reveals that the 721-0342 silicone gasket (2) was missing between the Hella brand relay and the plug (3) on the electrical harness. Moisture enters around the plug of the relay and can cause the relay to become corroded or shorted.

1. 725-1648 PTO Relay
2. 721-0342 Silicone Gasket
3. Plug on Electrical Harness

Solution: When replacing PTO relay located beneath the instrument panel, always use a silicone gasket as shown below. Some Series 2000 tractors used in production a Bosch brand PTO relay which does not require a silicone gasket. All current production Series 2000 tractors will use a silicone gasket regardless of brand.

Note: Silicone gasket is not included with PTO relay from service parts.
