CUB CADET ENGINES (4-CYCLE)

Affected Models: 7T84JHA, 7T84JUA, T90BW
Affected S/N Range: Engine Serial number 7/2018- 7/2020
Affected Parts: 794-00136; 994-00136 Ignition Coil
Date: October 8, 2020
Subject: Cold No Starts or Sticking Choke Interference found

FIX-AS-FAIL

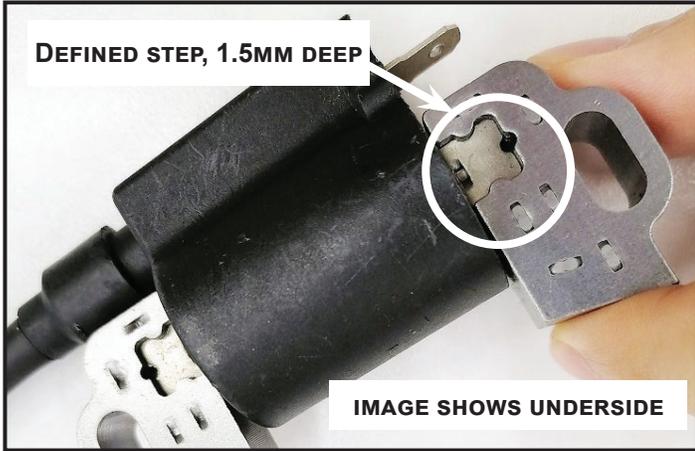
Figure 1

Purpose: Correcting a sticking Air Vane due to interference with the Ignition Coil wire. A step in the Coil laminate core allows the Air Vane to move directly into the Coil wire. The Ignition Coil must be replaced to correct this interference.

1. Identify a bad Ignition Coil. Remove Ignition coil from Engine. Turn over and inspect the underside. An Ignition coil with a 1.5mm step from the laminate core is a bad coil. See Figure 1.

3. When a bad ignition coil is found, it is in need of replacement. Order and install Ignition Coil 994-00136.

NOTE: To reinstall new coil: Set air gap of coil at 0.016"-0.024". Tighten the module mounting screws to a torque of 80-106 in-lbs (9-12 Nm).

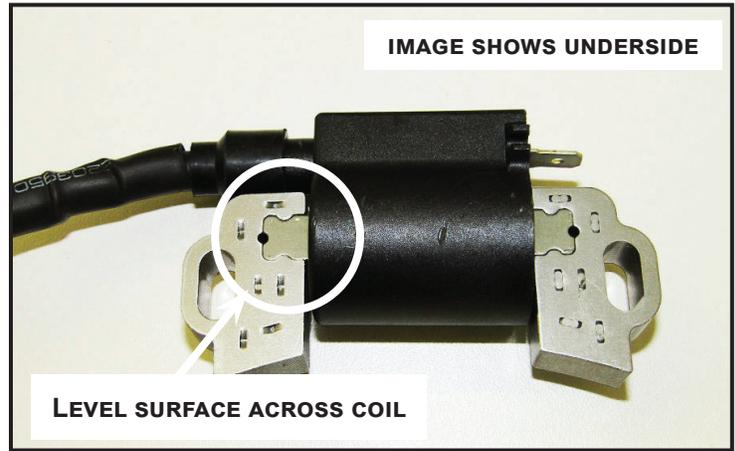
Figure 2

2. Identify a good Ignition Coil. A good coil will not have a step from the laminate core. See Figure 2.
