PROFESSIONAL SERIES (PRO-Z 500S, 700S, 900S)

Date: February 02, 2021

Subject: Optional Steering Shaft Flange Bushing

INFORMATIONAL ONLY

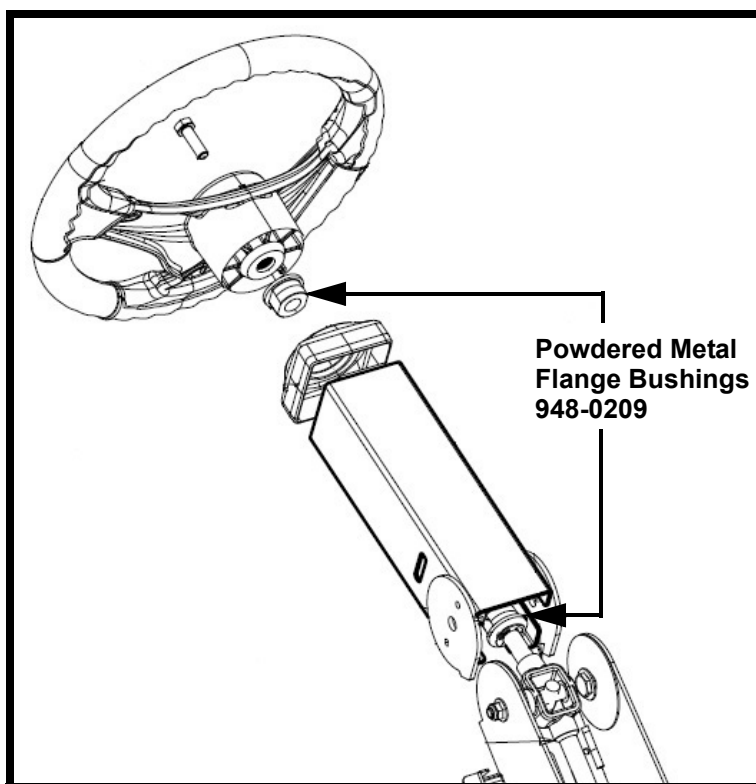
FIGURE 1

We have received reports of a rattling noise from the steering column. This rattling noise occurs from the two (2) powdered metal flange bushings **948-0209** located in the upper steering column. This is not a mechanical failure and this issue does not occur on every unit manufactured.

If your customer mentions or is annoyed about the rattling noise from the steering column, we now offer an optional flange bushing made of Delrin polymer material. This material is designed to replace metal components. It combines a low-friction and high wear resistance quality.
