Service Advisory

CC-559A

Models Affected: M48, M54, M60, M72 Tanks (Fabricated Decks)

Subject: **P.T.O. / Deck Drive Double Idler Kit FIX-AS-FAIL**

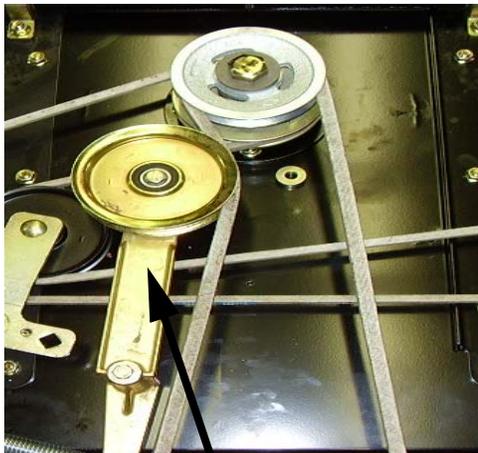
Original Idler Arm

PURPOSE: This Advisory is not mandatory for all decks but is a **FIX-AS-FAIL** remedy. The Double Idler Kit is to address units with P.T.O. belt issues, including premature wear or belt "jumping" off pulleys, usually on horizontal shaft engines. Order and install a **02003759** Double Idler Kit.

2006 & Prior With Gold Colored Cast Metal Or Welded Steel Arm & Single Flat Idler Pulley.

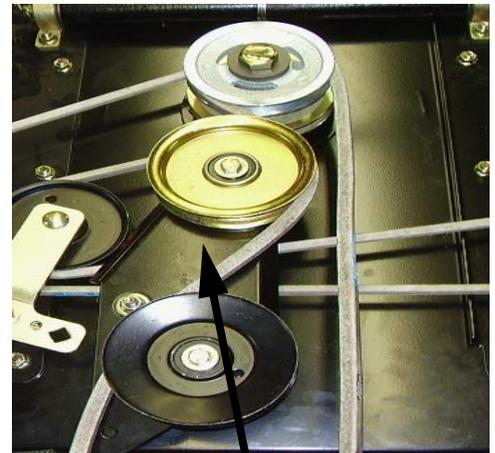
New Style Idler Arm

New Design With Double Pulley Configuration, One Flat Idler & One V-groove Pulley.

SOLUTION: The P.T.O. / Deck Drive Double Idler Kit incorporates a dual idler pulley system. The standard flat idler pulley is mounted along with a V-groove pulley. This configuration will provide constant belt tension & alignment throughout the deck height position range. The double idler system is available as a kit which will retrofit to work on 2006 & prior MMZ "TANK" Units with 48", 54", 60" or 72" fabricated decks equipped with horizontal or vertical shaft engines. The existing P.T.O. belt is used with the new double idler configuration.

Our testing has indicated that the double idler system reduces abnormal P.T.O. belt wear & lessens the chance of the belt being "thrown" off the idlers or drive pulleys. This is especially true when cutting at very high or very low deck settings or unique grass conditions. When engaging the P.T.O. clutch, belt slack is reduced. This is especially noted on units with horizontal shaft engines.
