CODE: CC-292

DATE: DECEMBER 21, 1994

SUBJECT: SERIES 2000 TRACTORS ( MODELS 2130 - 2185 )

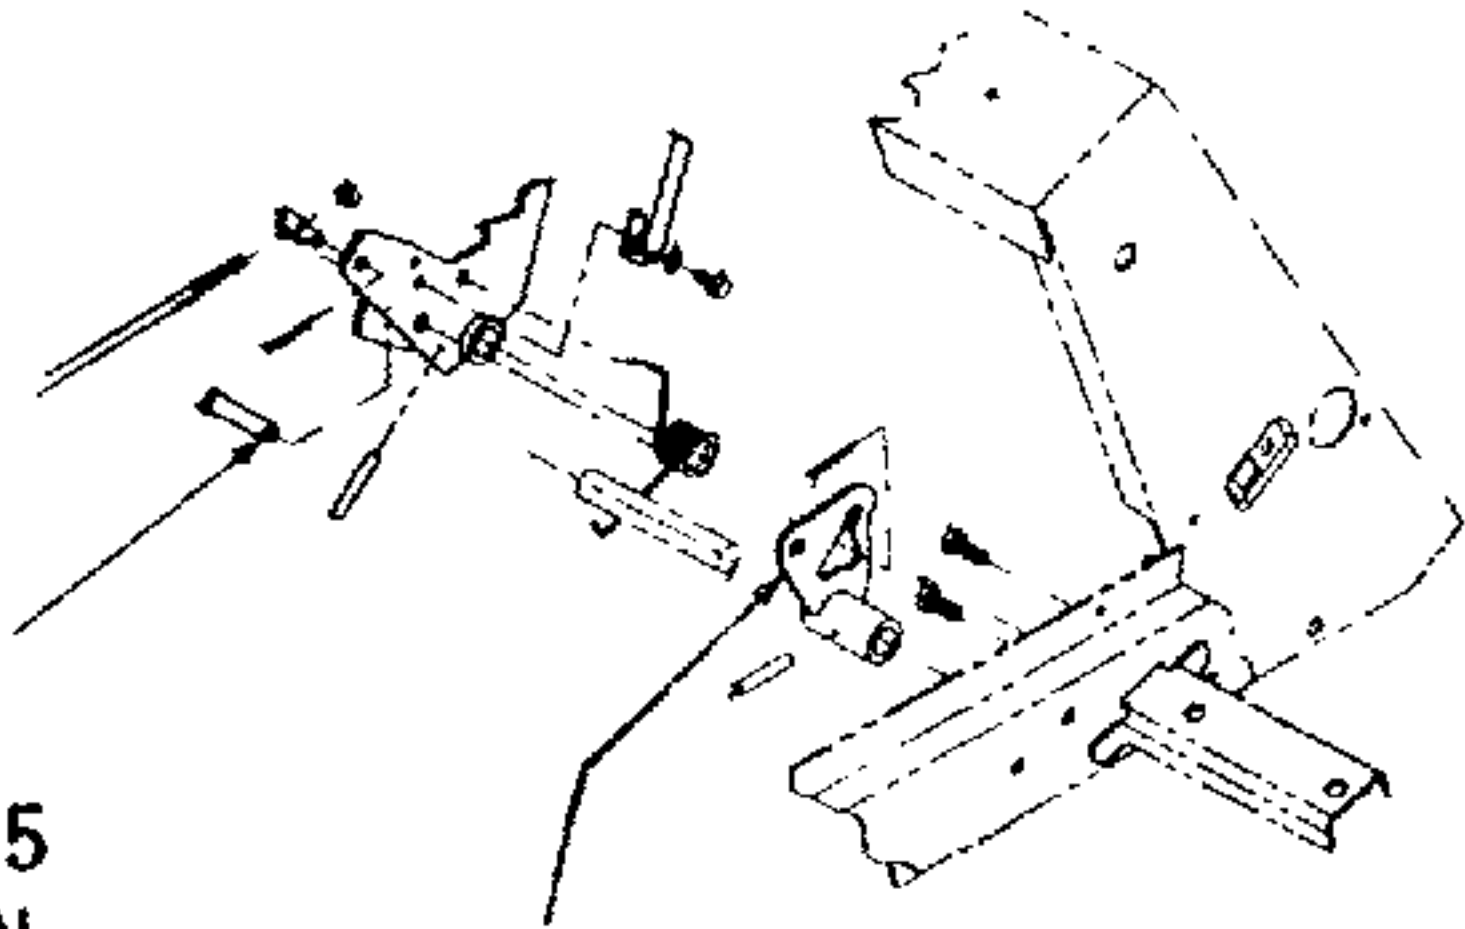
PROBLEM: WE HAVE RECEIVED SOME REPORTS FROM THE FIELD OF THE FORWARD AND REVERSE PEDALS BEING SLUGGISH WHEN RETURNING TO NEUTRAL. THE CLEVIS PIN (# 711-0415) IN SOME CASES MAY HAVE AN INTERFERENCE WITH THE NEUTRAL RETURN BRACKET (# 603-0215) SHOWN IN FIG. 2 BELOW.

#711-0415  
CLEVIS PIN

#603-0215  
NEUTRAL RETURN BRACKET

SOLUTION: REMOVE THE NEUTRAL RETURN BRACKET AND GRIND OUT THE INSIDE OF THE BRACKET FROM THE DOTTED LINE (SHOWN IN FIG. 1) DOWN APPROXIMATELY .100 TO ACHIEVE PROPER CLEARANCE FOR THE CLEVIS PIN.
