Service Advisory

CC-661

LTX1000 SERIES

Subject: **42" and 46" Decks' RH Idler Binding**

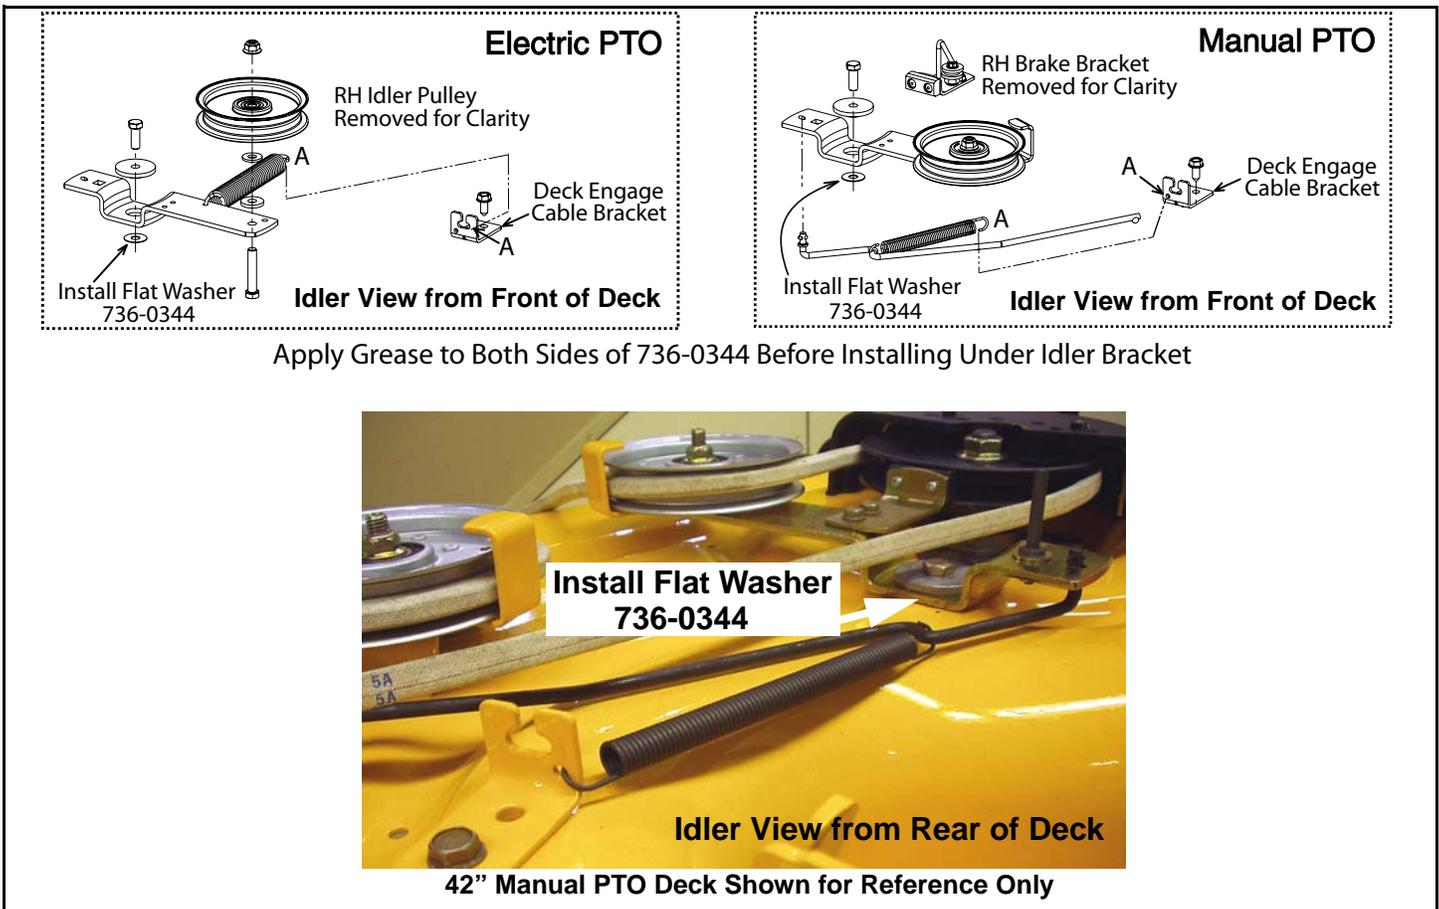
FIGURE 1

PURPOSE: Heavy debris build-up on the deck may cause the right hand idler bracket to bind resulting in degraded cutting performance.

PARTS REQUIRED: Qty. (1) = 736-0344 - Flat Washer: .385 I.D. x 1.0 O.D. x .030"

3. Allow engine and muffler to cool before proceeding.
4. To facilitate access to the RH tensioning idler remove deck from under the tractor.
5. Install a spacer washer in accordance with Figure 1.
