Affected Models: 7T84JHA, 7T84JUA, T90BW
Affected S/N Range: Engine Serial number 7/2018- 7/2020

Affected Parts: 794-00136; 994-00136 Ignition Coil

Date: October 8, 2020

Subject: Cold No Starts or Sticking Choke Interference found

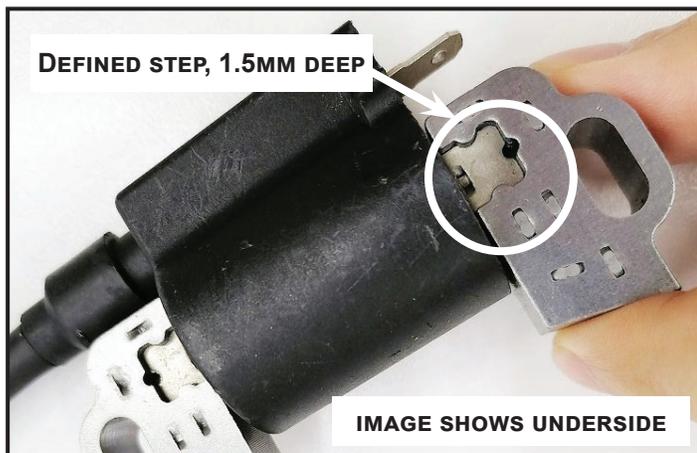
Figure 1

Purpose: Correcting a sticking Air Vane due to interference with the Ignition Coil wire. A step in the laminate core allows the Air Vane to move directly into the Coil wire. The Ignition Coil must be replaced to correct this interference.

1. Identify a bad Ignition Coil. Remove Ignition coil from Engine. Turn over and inspect the underside. An Ignition coil with a 1.5mm step from the laminate core is a bad coil. See Figure 1.

3. When a bad ignition coil is found, it is in need of replacement. Order and install Ignition coil 994-00136.

NOTE: To reinstall new coil: Set air gap of coil at 0.016"-0.024". Tighten the module mounting screws to a torque of 80-106 in-lbs (9-12 Nm).

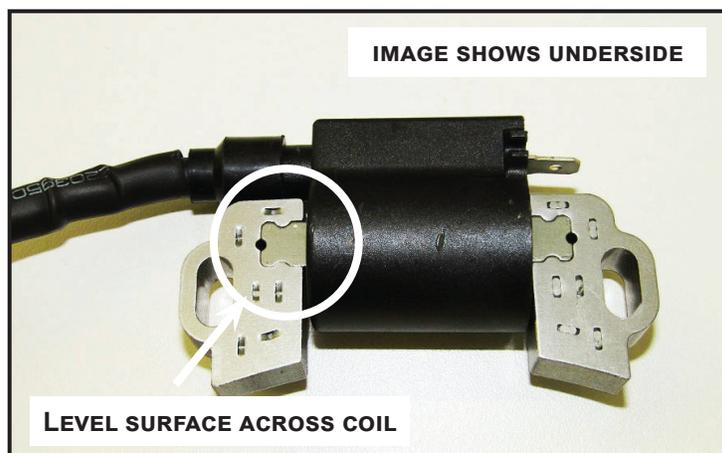
Figure 2

2. Identify a good Ignition Coil. A good coil will not have a step from the laminate core. See Figure 2.
