# Service Advisory

CC-557A

Subject: **46" Belt / Pulley and Idler Support Bracket Kit, 753-05436A**

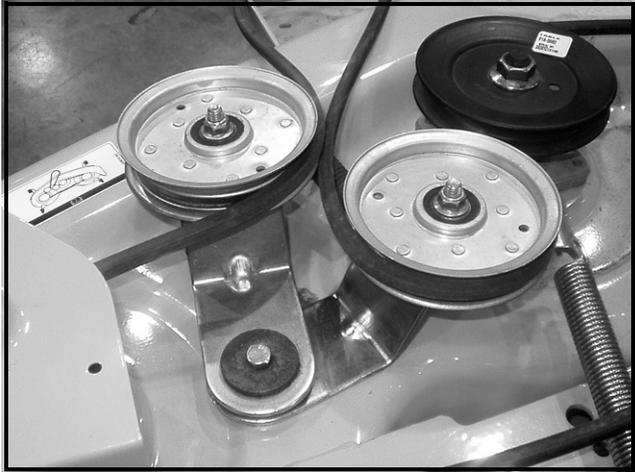
- Under certain loading conditions the two moveable idlers may pull in towards each other sufficiently to result in the deck drive belt inner surfaces rubbing together. This may lead to belt fraying and eventual belt failure. See Figure 1 on page 2.
- There have been a few reports of the deck drive belt jumping off of the idlers. It was found that the upper idler bracket had bent resulting in the upper idler pulley being too low and at an angle for the designed belt path.

**FIGURE 1** - This idler configuration shows none of the upgrades supplied in service kit 753-05436A.

Service kit **753-05436A** contains the necessary parts and hardware to address both symptoms.

The 754-04153 "V" Belt and 756-0627D (3.50" Diameter) Pulley addresses **Symptom 1**.  
 The 783-05463 Idler Support Bracket and 783-05118 Idler Bracket addresses **Symptom 2**.

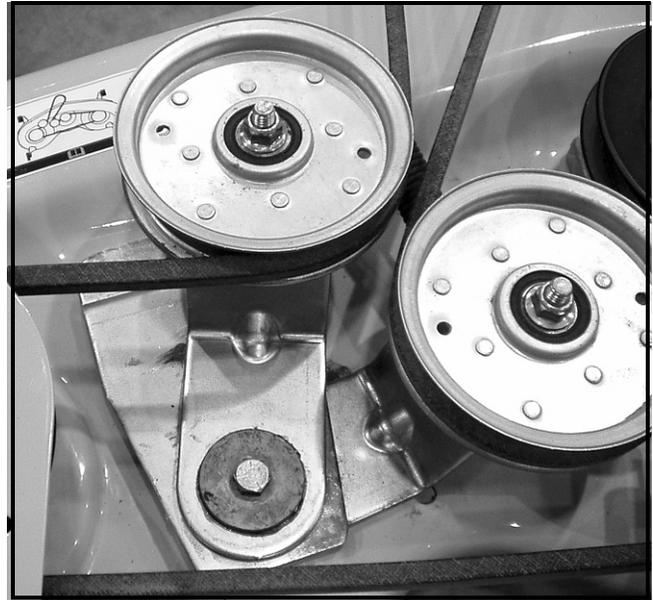
**FIGURE 3** - This idler configuration shows only the 783-05463 idler support bracket upgrade installed.

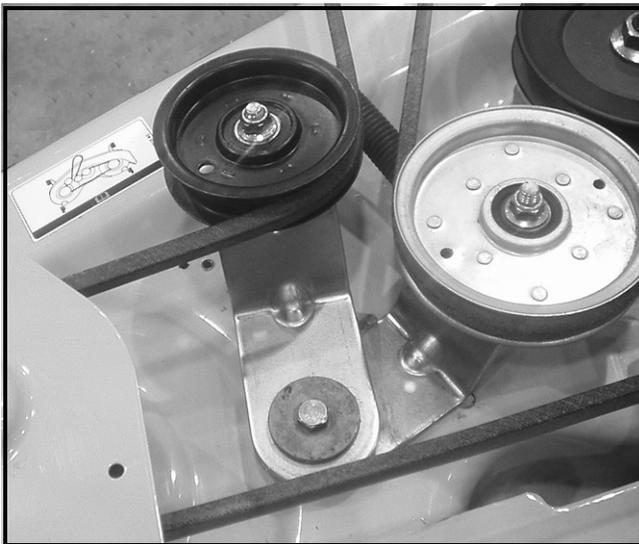
**FIGURE 2** - This idler configuration shows the 756-0627D smaller idler pulley and 754-04153 "V" belt upgrade only installed.

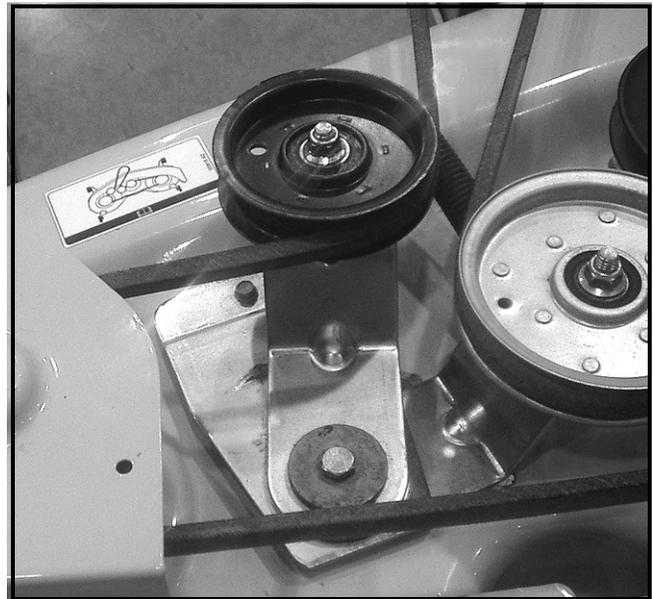
**FIGURE 4** - This idler configuration shows both upgrades supplied in service kit 753-05436A. Installed: 756-0627D smaller idler pulley, 754-04153 "V" belt, 783-05463 idler support bracket, plus 783-05118 idler bracket.

- Some of the **Models Affected** resulted in the 46" decks not having either or some partial upgrade as provided in service kit 753-05436A. See attached service kit instruction sheet.
- Figures 1 thru 3 show possible idler configurations that are affected in the **Serial Number Range**. Figure 4 shows the idler configuration with both upgrades installed.
- Review Figures 1 through 3 to determine which matches your deck idler configuration. Determine what parts from service kit 753-05436A are required so that the idler configuration will be as shown in Figure 4. The new idler bracket, 783-05118 supplied in the kit, should be replaced in all cases.
