## Power Equipment

Code: CC-304

Date: June 19, 1995

SUBJECT: POWER TAKE OFF (PTO) CLUTCH SPACER ON 2130, 2135, 2160, 2165, 2185, 1440, 1641 MODEL TRACTORS. (1995 PRODUCTION)

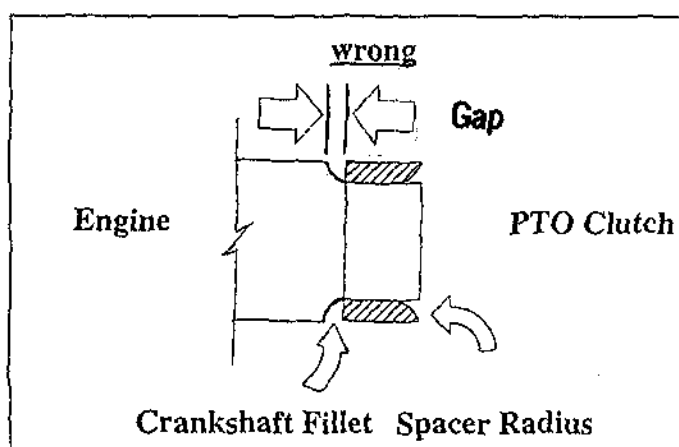
Figure 1

The following instructions are a visual way the service technician can quickly determine if the spacer has been installed properly. First the service technician must remove both side panels from the tractor in an area with plenty of light. Next look behind the PTO clutch, examine the area where the spacer comes in contact with the fillet of the crankshaft as shown in the illustrations below. If improperly installed, a gap will be apparent between the fillet of the crankshaft and the spacer as shown in figure one. If properly installed, the radius of the spacer will be in contact with the fillet of the crankshaft as shown in figure two.
