# Service Advisory

CC-509

Models Affected: RZT 42 (17AA5B4G709, 17AA5B4G710)  
RZT 50 (17AA5D7P709, 17AA5D7P710, 17AA5D7P756)

Subject: **Bypass Rod (747-04217C)**

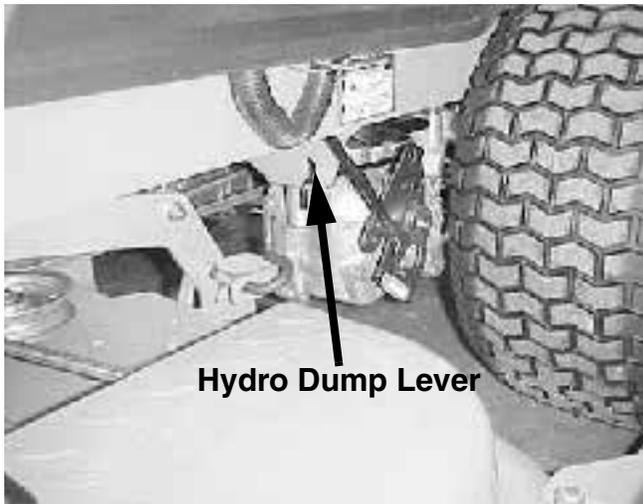
**FIGURE 1.**

**PURPOSE:** To bring attention to the hydro bypass rod not being able to be released / activated when the cutting deck is in the highest position.

Lower the cutting deck to the lowest position. Locate the hydro bypass rod located on the left side of the unit, the dump rod faces the front of the unit with the lever facing down as shown in Figure 1.
