## ZERO TURN SERIES

**Range Affected:** 1B175G through 2009 (February 17, 2005 through 2009).

**Subject:** Failure Of Welds Of The P.T.O. Clutch Torque Bracket To The Frame.

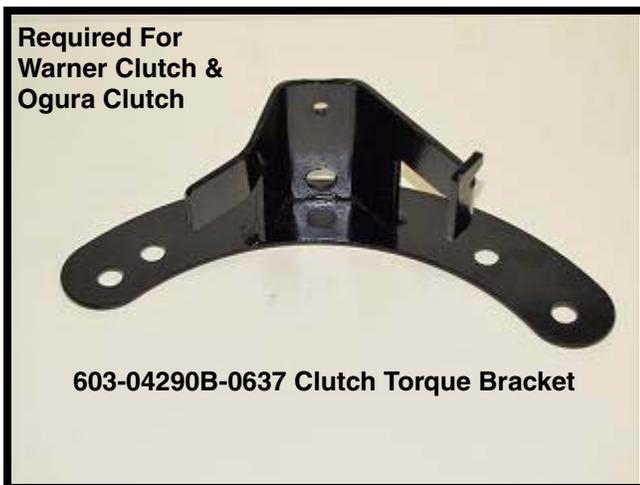
**FIGURE 1**

**NOTE:** When installing **603-04290B-0637 P.T.O. Clutch Torque Bracket (Figure 1)** and an Ogura clutch is still being used, also order and install **703-05845 Anti-Rotation Bracket (Figure 2)**. See Service Advisory CC-491 for installation of Anti-Rotation Bracket or photo's on Back of this Service Advisory.

If a failure of the welds on the P.T.O. Clutch Torque Bracket occurs the replacement of the frame is no longer needed. A P.T.O. Clutch Torque Bracket **603-04290B-0637** is now available as a bolt on service replacement part.

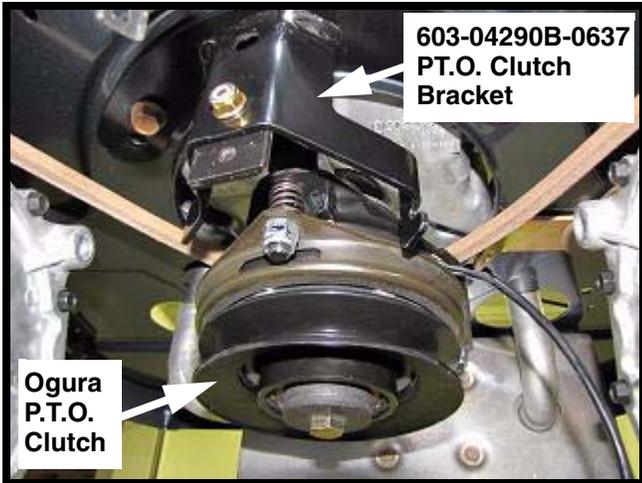
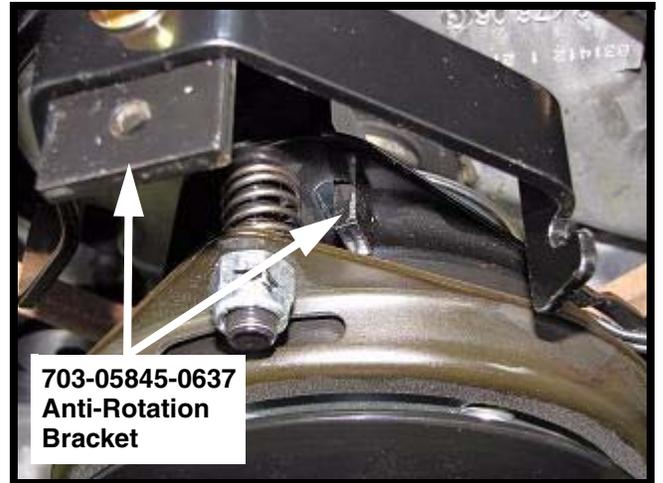
Figures 3 and 4 below show a **603-04290B-0637** P.T.O. Clutch Bracket with the **703-05845-0637** Anti-Rotation Bracket installed for anchoring an Ogura P.T.O. Clutch. See Service Advisory CC-491 for complete installation instructions of the Anti-Rotation Bracket.

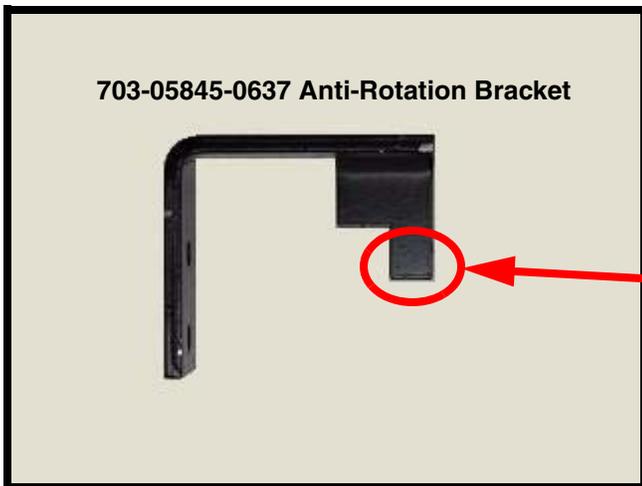
**FIGURE 5**

Figure 5 below highlights the part of the **703-05845-0637** Anti-Rotation Bracket that passes through the oval slot (Figure 6) in the Ogura P.T.O. Clutch to keep the clutch from rotating.
