Models: 3165, 3184, 3185, 3186, 3205, 3206, 3208, 3225, 3235, 3240

Date: September 10, 2001

Subject: CRUISE CONTROL ADJUSTMENTS

WARRANTY: NONE Service Advisory CC-415 is being released for information.

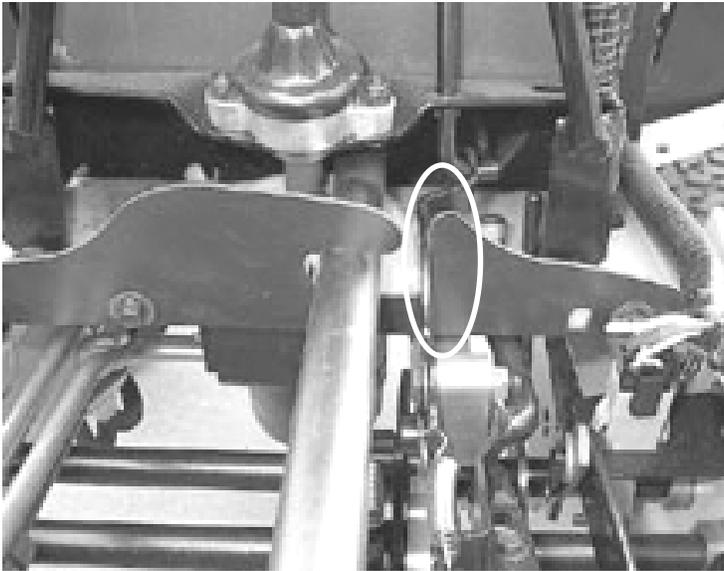
Figure 1

Inspect the intake flap for contact with the rod adjustment bracket in the engaged position. See figure 1. If any contact is observed, trim the rubber flap as needed to allow for operational clearance

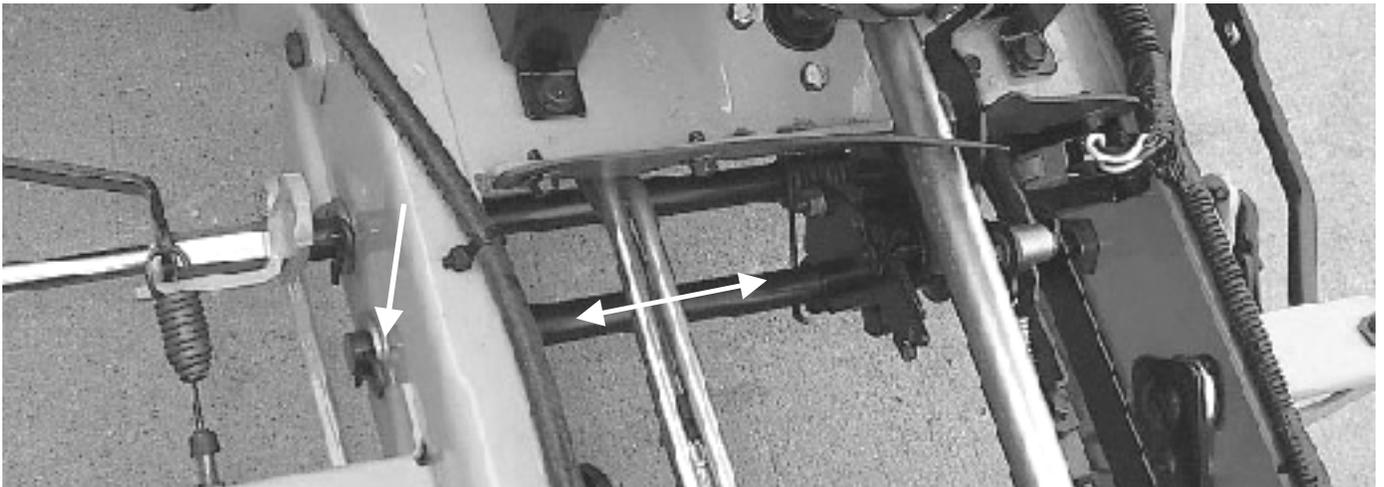
Figure 2

- Grasp the pedal shaft assembly and try to move it side to side. See figure 2. If any excessive side to side movement is noted, remove the cotter pin from the left side of the shaft and install either wave washer 736-0621 or flat washer(s) 736-0287 between the cotter pin and frame bushing to reduce the side to side play. Verify the shaft is free to pivot after the installation of any washers. **THERE SHOULD BE NO BINDING OF THE SHAFT ROTATION!**

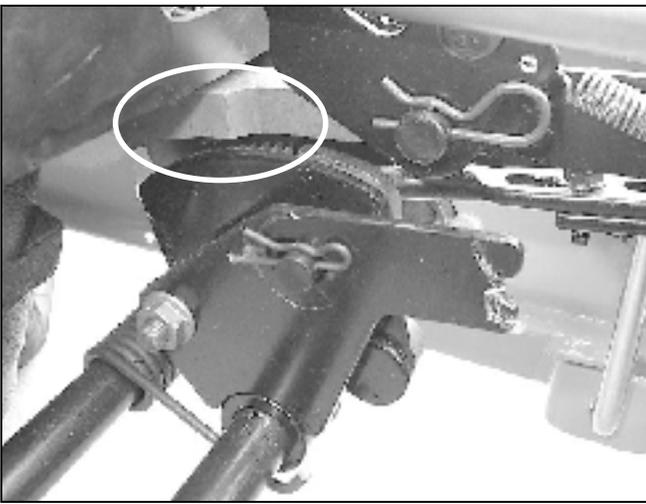
Figure 3

- Inspect the cruise latch and the cruise plate for any damage to the engagement teeth. If any damage is evident, replace damaged parts as needed. See figure 3 on next page.

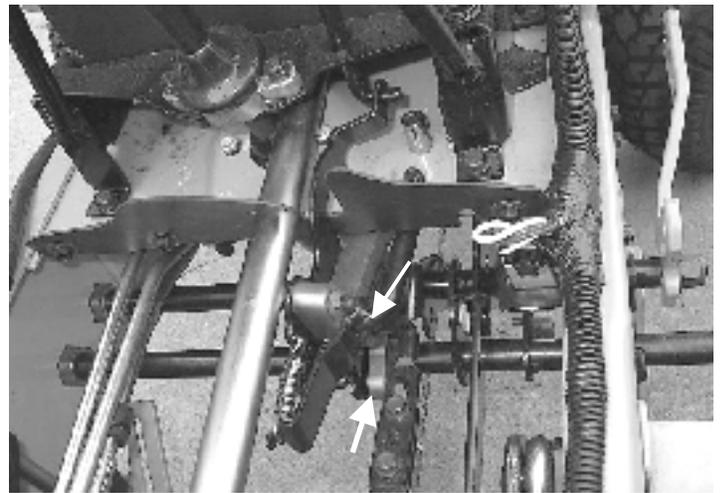
Figure 4

- Inspect the pedal shaft and cruise rod assembly for excessive paint buildup in the areas of cruise latch pivot point and the cruise plate pivot point. See figure 4 on next page. Remove any paint buildup from the areas and apply a light coat of anti-seize to prevent rusting and binding of the components.

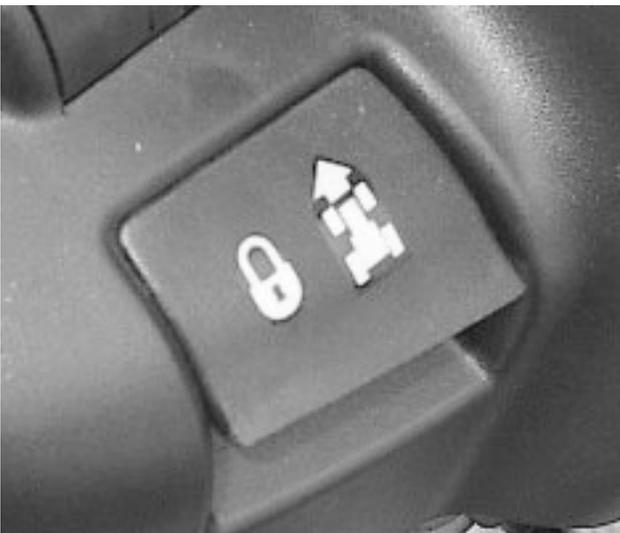
Figure 5

- Make sure the cruise lever is firmly seated against the dash panel as shown in figure 5 on next page by lightly lifting up on the lever. If any movement observed or a gap is noted as shown in figure 6 on next page, the rod adjustment bracket will need to be adjusted in step 3. Also make sure the cruise lever is free to move and does not bind against the dash panel in any area. Carefully remove any material that may cause a bind if any is evident.

- Loosen bolt 710-0106 (1/4-20 x 1.25) and lock nut 712-3027 (1/4-20) that secures the rod adjust bracket 703-3020 to the cruise latch. See figure 9. Lift the rearmost end of the rod adjust bracket until the cruise lever contacts the upper surface of the opening in the dash panel. See figure 5. Hold the rod adjust bracket in this position and lower the cruise latch. The cruise latch teeth should clear the cruise plate teeth by about .020 to .030. Tighten bolt and nut securely.

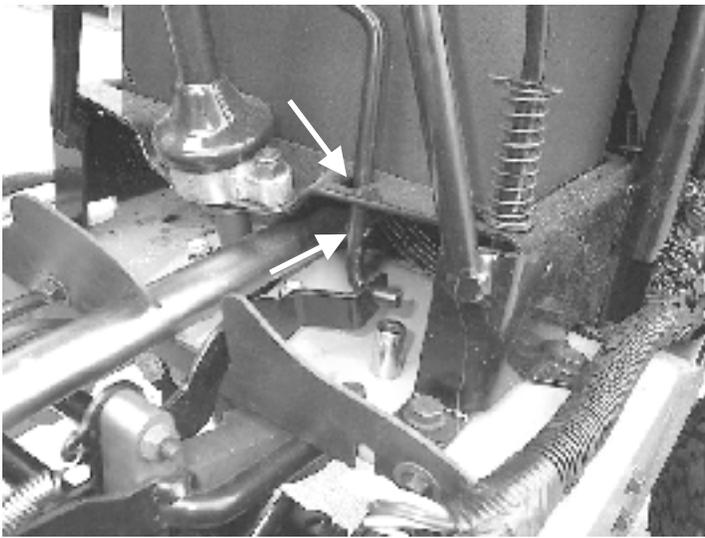
Figure 7

- Inspect the slot in the pedestal where the cruise control rod passes through. See figure 7 on next page. If any binding or contact of the rod occurs against the slot, carefully “open up” the slot with a die grinder or file. There are “nubs” formed into the cruise control rod below the pedestal level, remove these “nubs” with a die grinder or file to reduce the possibility of contact with the pedestal.
- Inspect the disengagement plate for paint buildup on the uppermost surface. See figure 8 on next page. Remove paint from this surface if present.
- Make sure that all pivot bushings and linkage components are mechanically intact. Make the repairs as needed before performing the following adjustments in step 3.

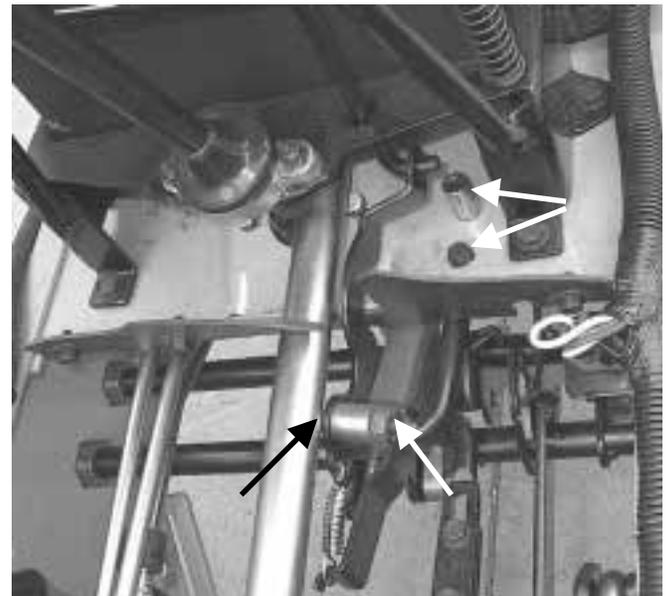
Figure 9

- Loosen the (2) bolts 710-0642 (1/4-20 x .75) that secure the cruise rod assembly to the frame. See figure 9 on next page.
- Adjust the cruise latch 748-3060 side to side for proper alignment with the cruise plate 748-3080.

- SNUG the forward most bolt and verify that the cruise rod assembly has not pivoted to misalign the teeth of the cruise latch and cruise plate. The entire width of the tooth must make contact.

- Tighten the rearward bolt and then tighten the forward bolt. Verify the cruise rod assembly has not pivoted out of position during this step. The cruise latch teeth **MUST** remain parallel with the cruise plate teeth.

- Set the cruise control and visually confirm that the cruise latch teeth are engaging to full depth into the cruise plate teeth. Readjust the rod adjust bracket if the teeth will not engage to full depth.
