Service Advisory

CC-684

Models Affected: **S6031-KW** (53A18DU6050).
S7237-KW (53A18DU8050).

Subject: **Mandatory Check Of The Steering Housing Assembly Flange Bearings 02003163 and 02004002.**

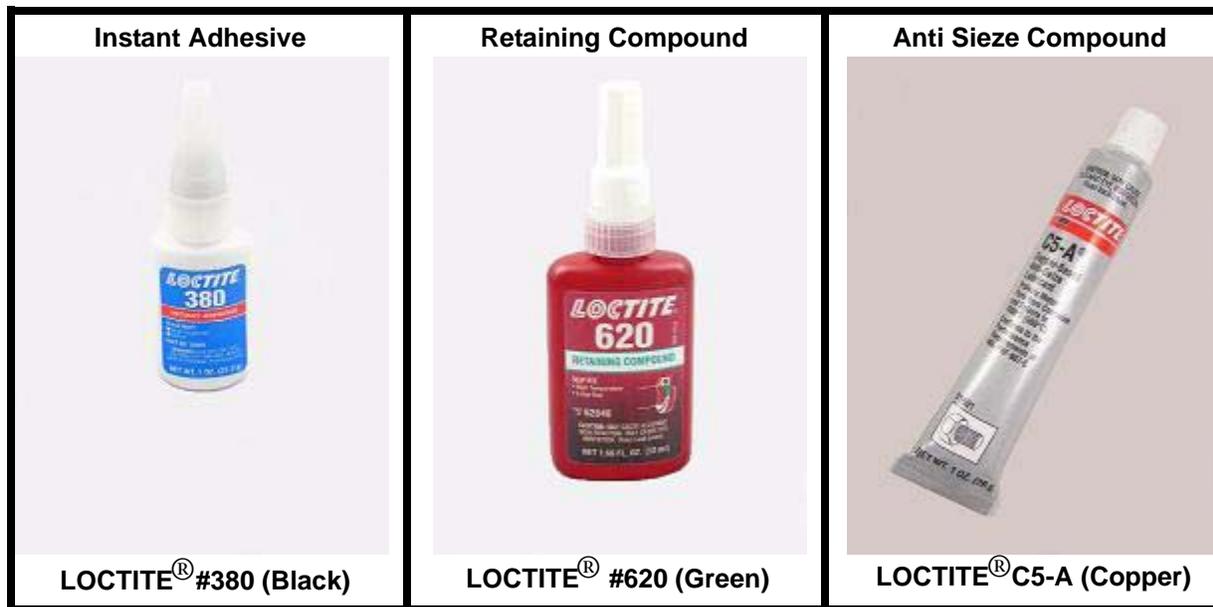
FIGURE 1

ACTION REQUIRED: The recommended or equivalent shop supplies to complete this repair are available locally. The three (3) items are listed below for reference. These items are not covered by warranty.

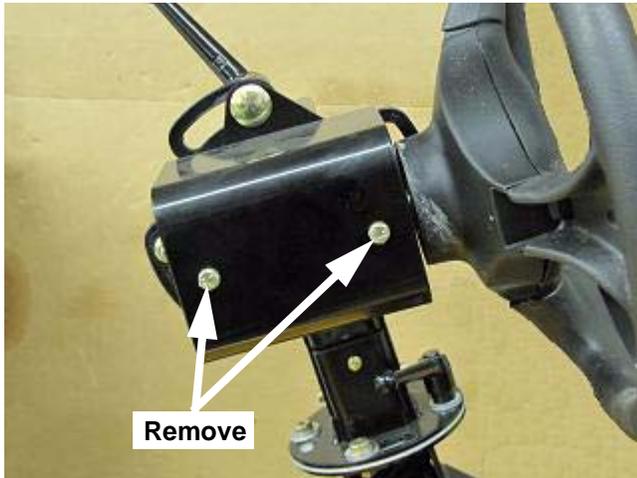
FIGURE 2

1. Park unit on a flat level surface.
2. Disconnect the negative battery cable from the negative battery terminal. Disconnect the positive battery cable from the positive battery terminal.
3. Remove the two (2) 1/4-20 x .75" hex cap screws and lock washers that secure the steering housing assembly cover in place. See Figure 2.

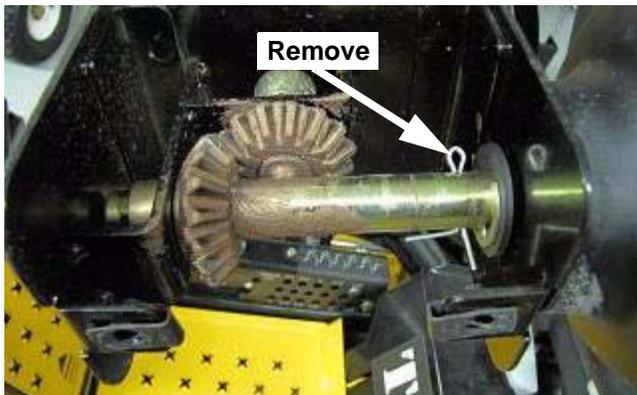
FIGURE 3

4. Remove the cotter pin from the steering shaft. See Figure 3.

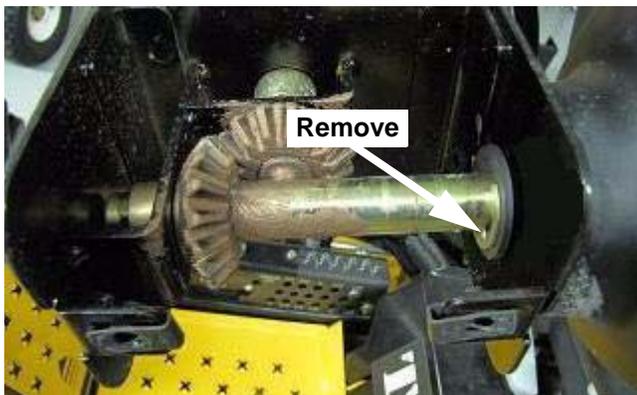
FIGURE 4

5. Remove the 3/4" diameter E-clip from the steering shaft. See Figure 4.

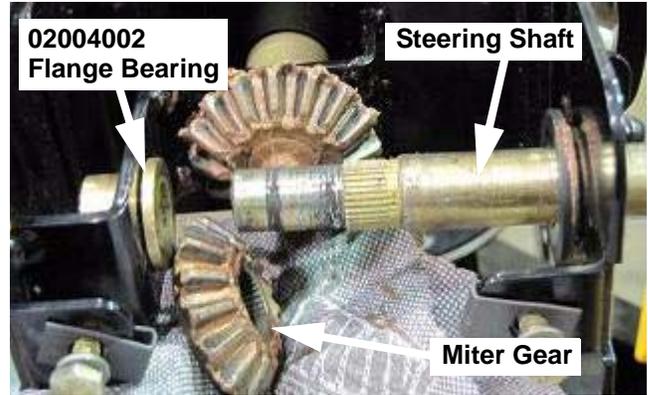
FIGURE 5

6. Pull the steering wheel with steering shaft from the **02004002** flange bearing and miter gear. See Figure 5.
NOTE: Do Not allow the miter gear fall.

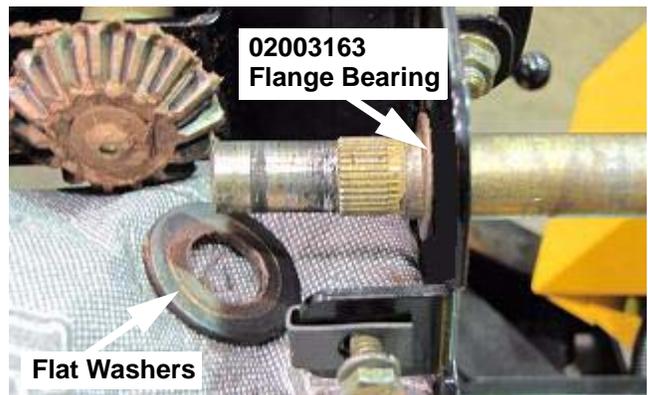
FIGURE 6

7. Pull the steering wheel and shaft from the remaining **02003163** flange bearing and catch the two (2) flat washers located on the steering shaft as it is pulled through the **02003163** flange bearing. See Figure 6.

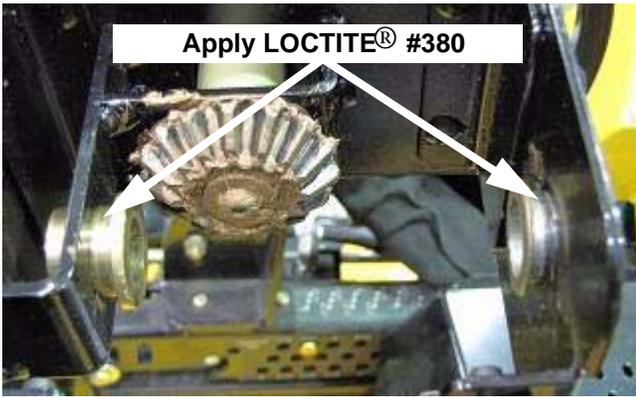
FIGURE 7

8. Check that the steering shaft flange bearings **02003163** and **02004002** are secure in the steering housing assembly, unable to turn or move in or out of their respective location.
9. If there is sufficient damage to the integrity of the hole or the flange bearings, order a new steering housing assembly and flange bearings and continue to follow these instructions for retaining the flange bearings in the steering housing assembly.
10. If the flange bearings are loose and no damage is evident to the steering housing assembly or the flange bearings, apply LOCTITE® #380 instant adhesive to the outer part of the bushings as shown in Figure 7.

11. Press the flange bearings back in place, with the flanges fully seated against the steering housing assembly.

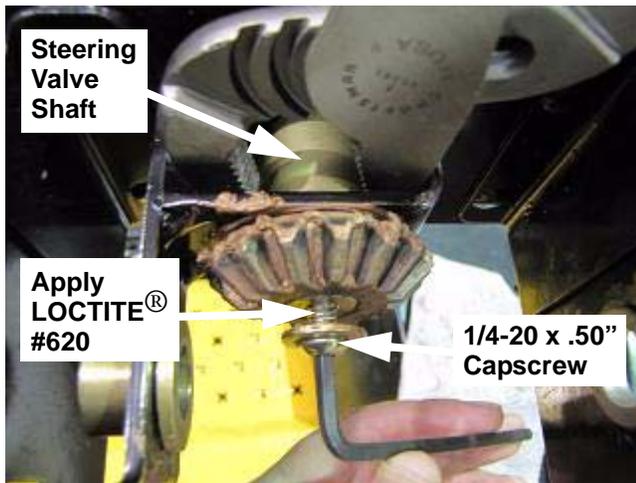
FIGURE 8

12. Retain the steering valve shaft from turning with a pair of channel lock pliers. Back out the 1/4-20 x .50" capscrew and apply a small amount of LOCTITE® #620 to the threads of the capscrew. See Figure 8.

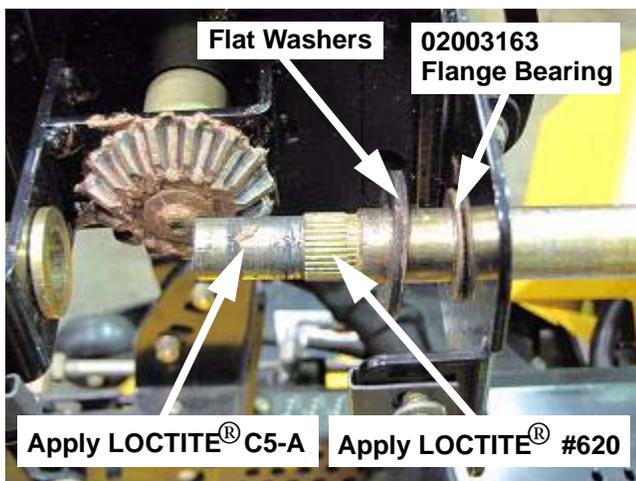
FIGURE 9

13. Install the steering shaft with steering wheel attached, through the 02003163 flange bearing. Install the two (2) flat washers onto the steering shaft. See Figure 9.

14. Apply a small amount of LOCTITE® C5-A (copper) anti-sieze compound to the steering shaft surface called out in Figure 9.

15. Apply a small amount of LOCTITE® #620 retaining compound to the splines of the steering shaft as called out in Figure 9.

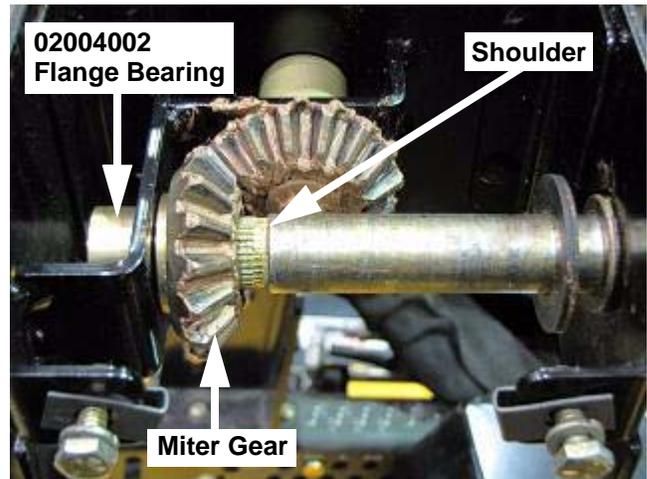
FIGURE 10

16. Position the miter gear in place in front of the 02004002 flange bearing. Push the steering wheel and steering shaft assembly into the miter gear. See Figure 10.

18. Push the steering wheel and steering shaft assembly in until the shoulder of the steering shaft (shown in Figure 10), bottoms out against the miter gear.

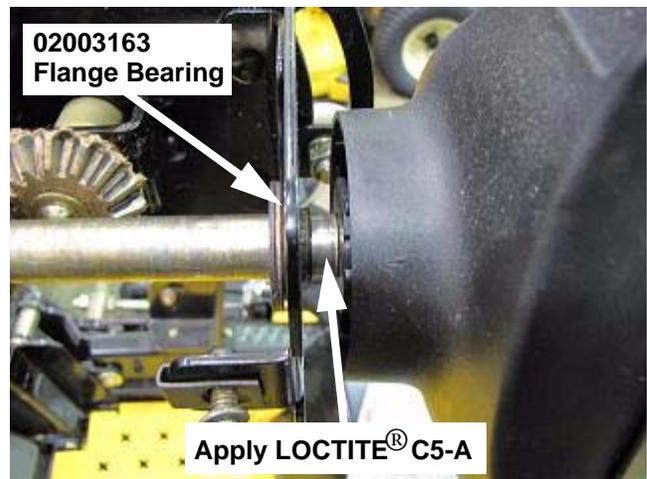
FIGURE 11

17. Apply a small amount of LOCTITE® C5-A on the steering shaft in the area shown in Figure 11.

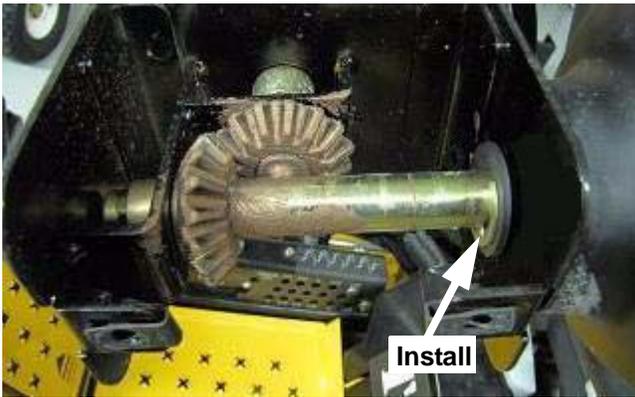
FIGURE 12

19. Install the e-ring in the groove of the steering shaft as shown in Figure 12.

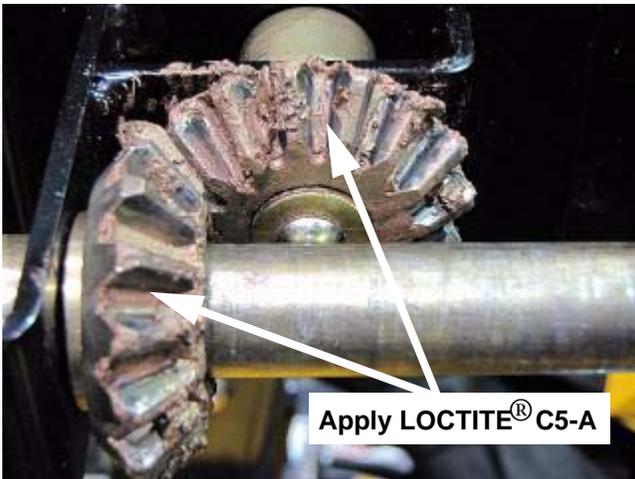
FIGURE 13

21. Apply LOCTITE[®] C5-A (copper) to the to miter gear surfaces as indicated in Figure 13.

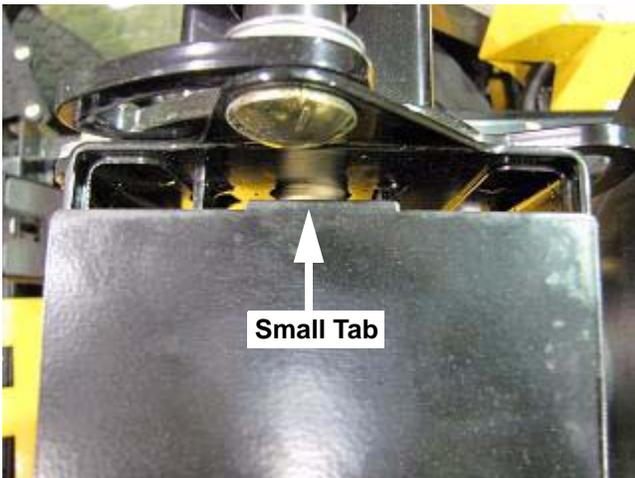
FIGURE 14

22. Install the steering box cover. **NOTE: The small tab side goes to the top as shown in Figure 14.**

23. Install the two (2) 1/4-20 x .75" hex cap screws and lock washers to secure the steering box cover in place.
