Models: 2135, 2155, 2165, 2185 S/N 326001 and above

Date: May 23, 1996

Subject: Cruise Control Adjustment

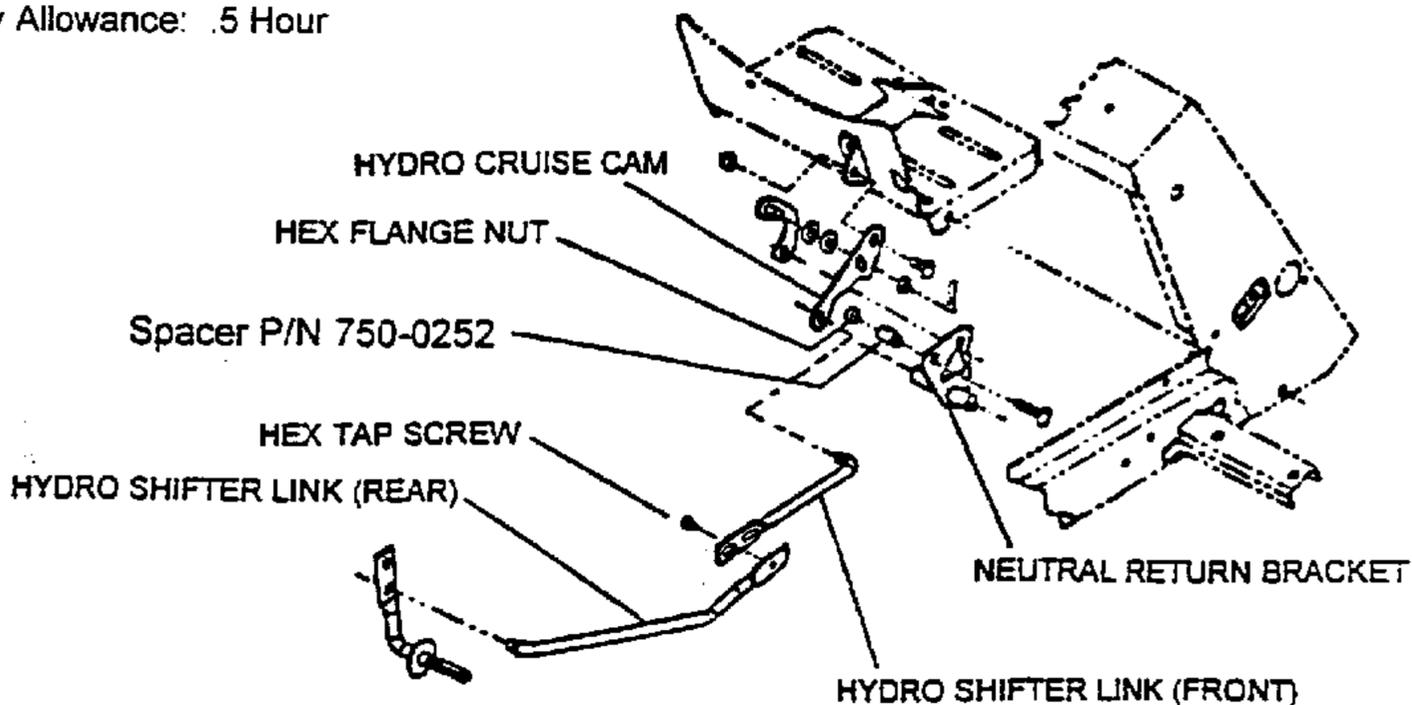
With the cruise control lever set in full forward position, the forward control foot pedal will also be locked in a full forward position. If not, the hydro shift links are out of adjustment and following procedure will be required.

1. Hold the forward control foot pedal in a fully forward position and push the cruise control lever also in a full forward position.
2. Hydro shifter front and rear links are adjustable by loosening the hex tap screw located at the center where two links meet (refer to illustration below). With the forward control foot pedal in a fully forward position, lengthen the links so the hydro cruise cam will contact the spacer located on the neutral return bracket.
3. If additional length is needed, remove the hex flange nut and discard 750-0252 spacer. Order and replace with P/N 750-3119 spacer and complete reassembly. After installing, refer to step two for adjustments. This will increase the overall diameter from the original spacer allowing the hydro cruise cam to lock the forward foot pedal in a full forward position.
