Service Advisory

CC-559A

Models Affected: M48, M54, M60, M72 Tanks (Fabricated Decks)

Subject: **P.T.O. / Deck Drive Double Idler Kit FIX-AS-FAIL**

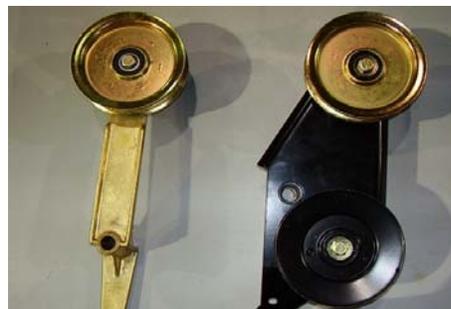
New Style Idler Arm

New Design With Double Pulley Configuration, One Flat Idler & One V-groove Pulley.

Our testing has indicated that the double idler system reduces abnormal P.T.O. belt wear & lessens the chance of the belt being "thrown" off the idlers or drive pulleys. This is especially true when cutting at very high or very low deck settings or unique grass conditions. When engaging the P.T.O. clutch, belt slack is reduced. This is especially noted on units with horizontal shaft engines.

SOLUTION: The P.T.O. / Deck Drive Double Idler Kit incorporates a dual idler pulley system. The standard flat idler pulley is mounted along with a V-groove pulley. This configuration will provide constant belt tension & alignment throughout the deck height position range. The double idler system is available as a kit which will retrofit to work on 2006 & prior MMZ "TANK" Units with 48", 54", 60" or 72" fabricated decks equipped with horizontal or vertical shaft engines. The existing P.T.O. belt is used with the new double idler configuration.
