### PRO-Z SERIES (PRO-Z 100 Series)

**Subject:** Possible Kinked Oil Lines On The Remote Oil Filter

**MANDATORY REPAIR**

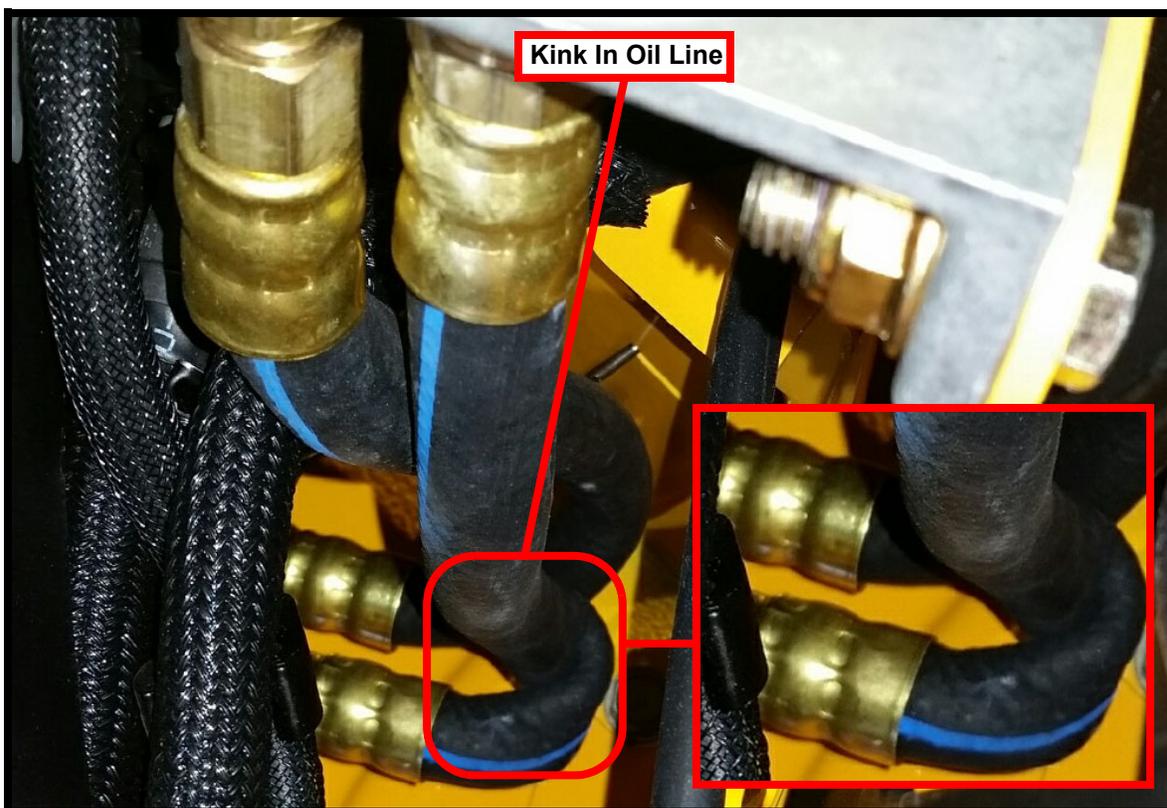
**FIGURE 1**

We have received reports of the oil lines possibly being kinked. This can cause the engine to be compromised of sufficient oil lubrication. Figure 1 shows one of the remote oil lines kinked.

1. Please inspect all PRO-Z 100 Models listed above in your dealer inventory. Follow the procedures listed on page 2 of this Advisory for inspecting the remote oil lines and removing the kink if needed.
