MTD ENGINES (Vertical)

Part Affected: 711-06413 Camshaft
Engine Model Affected: 4X90HU MTD X90 Series Vertical Shaft Engines
Date: March 27, 2017
Subject: X90 Cam/Tappet Kit 753-08688

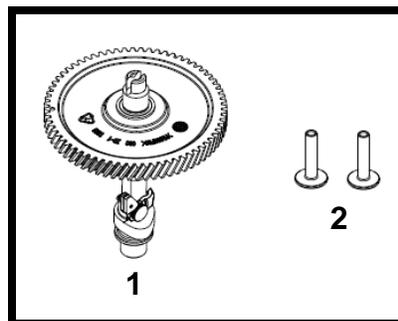
FIGURE 1

Service Kit Contents

(See Figure 1)

If a customer is complaining of low power / hard starting on a unit with the above mentioned engine, check the intake lobe of the camshaft to see if the lobe is wearing. If wear is confirmed order a **753-08688** X90 Cam/Tappet Kit.
